RESTORATION PLAN FOR 6910 SILVER STREET, WEST LINCOLN

FILE NO: C25070
OCTOBER 2025

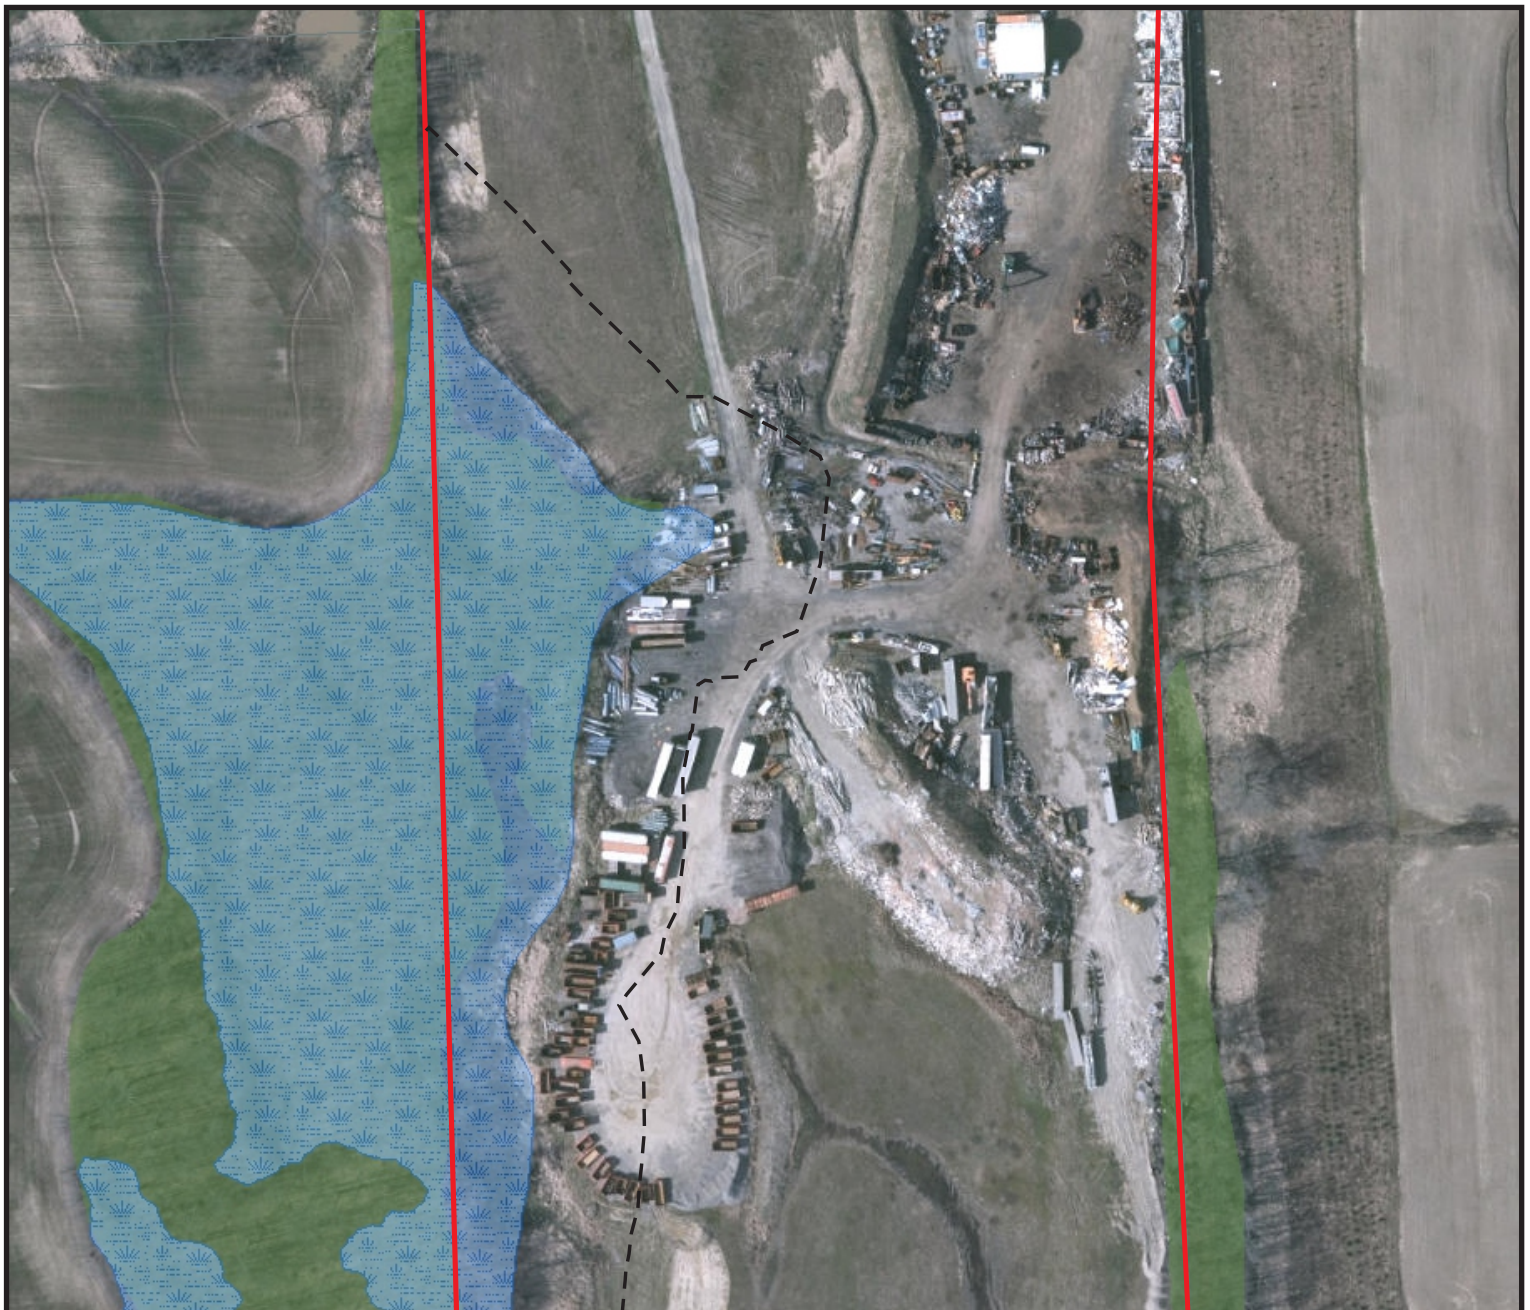
Figure 2
Mapped Natural Heritage Features
on the Subject Lands

- Property Boundaries
- - - - - 30 Meter Wetland Boundary
- Provincially Significant Wetland
- Other Woodland

The aim of this plan will be to restore and rehabilitate the buffer area affected by the business' operations while maintaining the current operation based on current site conditions. The approximate extent of the restoration area is illustrated in Figure 2.

As shown in Figure 2, there is a considerable amount of material and equipment adjacent to the mapped wetland. Also not shown on current aerial photography is the large shale pile also within the wetland buffer. It is recommended that all of this equipment and material be removed and brought outside of the line shown in Figure 3. This line is a slightly modified line from the 30m setback from the wetland. This adjusted line maintains the majority of the 30m buffer, which based on site assessments is more than appropriate buffer from the marginal wetland along the edge of the mapped PSW. This line verges slightly off the 30m buffer along the edge of the laneway. This laneway was constructed almost 15 years ago and removing it will greatly affect the day to day operations of the property. Based on assessments of the adjacent lands surrounding the laneway, it appears that the area is both dry and currently in active agricultural production. There will still be just over a 5m buffer from the currently mapped PSW. Based on site assessments, a 5m buffer along the laneway is appropriate. Any material and equipment west of the laneway currently within this buffer is recommended for removal. This includes any gravel/pavement placed as part of the scrapyard.
