Terra-Dynamics Consulting Inc.

Re: Karst Assessment, Stage 3A, Lockbridge Development Inc., Smithville, ON

1.0 Introduction and Background Information

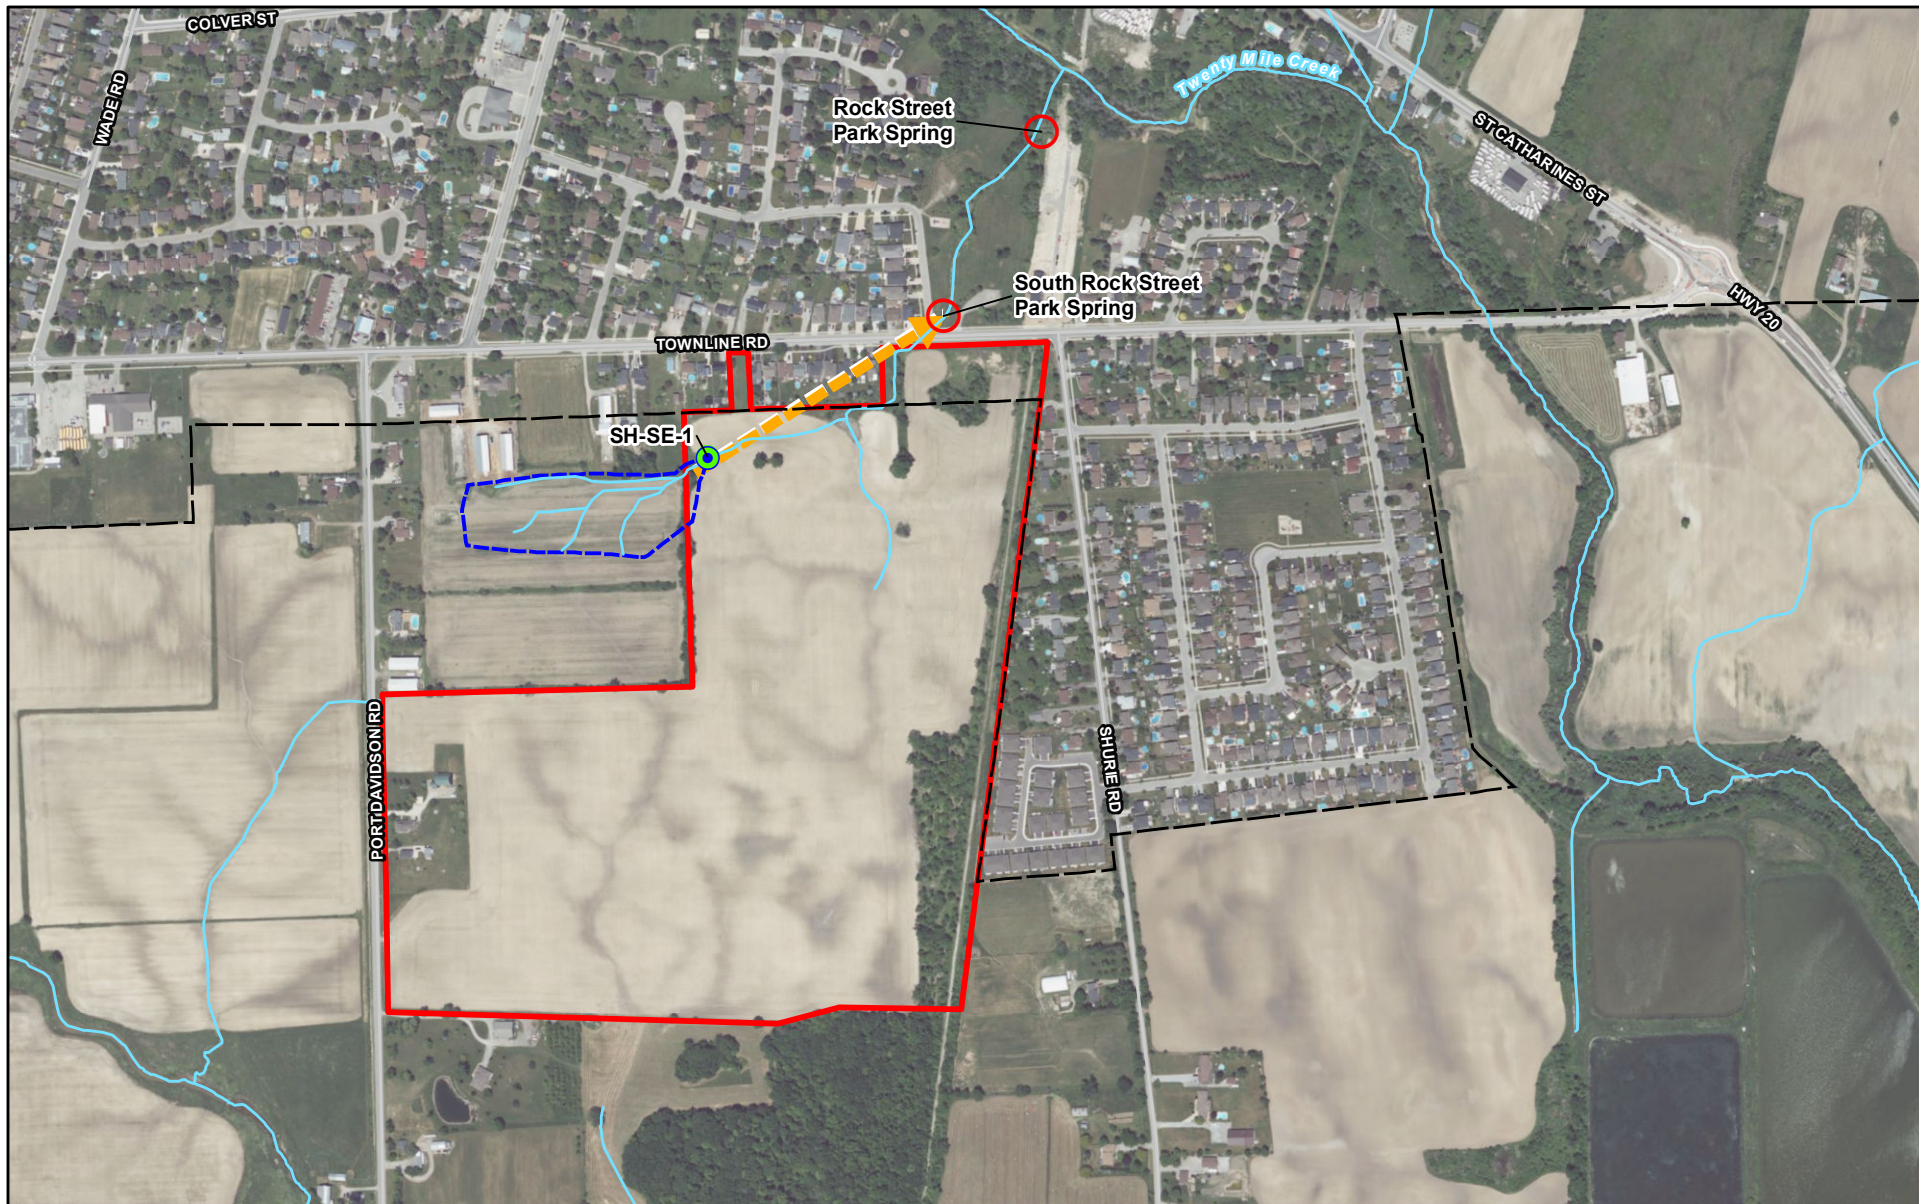
Figure 2

- Study Area
- Smithville
- Sinkhole
- Spring
- ➔ SH-SE-1 Straight-Line Representation of Karst Conduit (2024 Dye Tracing Results)
- Drainage Channel
- Approximate Catchment of Inflow to Sinkhole SE-1

SH-SE-1 is located on the northern portion of the Study Area, immediately northeast of a hedgerow (Figure 2). Flows enter the sinkhole from the southwest through a well-defined channel in the clay overburden that receives flows from the west and south. When flows into SH-SE-1 are at a greater rate than the infiltration capacity of the sinkhole, water ponds up in the depression of the sinkhole and if water levels become high enough, flows will continue past the sinkhole in an eastward and then northward direction, passing under Townline Rd. and entering Rock Street Park. The following table presents some general information for SH-SE-1:

The water that does not infiltrate into SH-SE-1 during high flows will inundate SH-SE-1 and then flow in a northeast direction, through a culvert under Townline Road and then through Rock Street Park before discharging into Twenty Mile Creek (Figures 2 and 3).

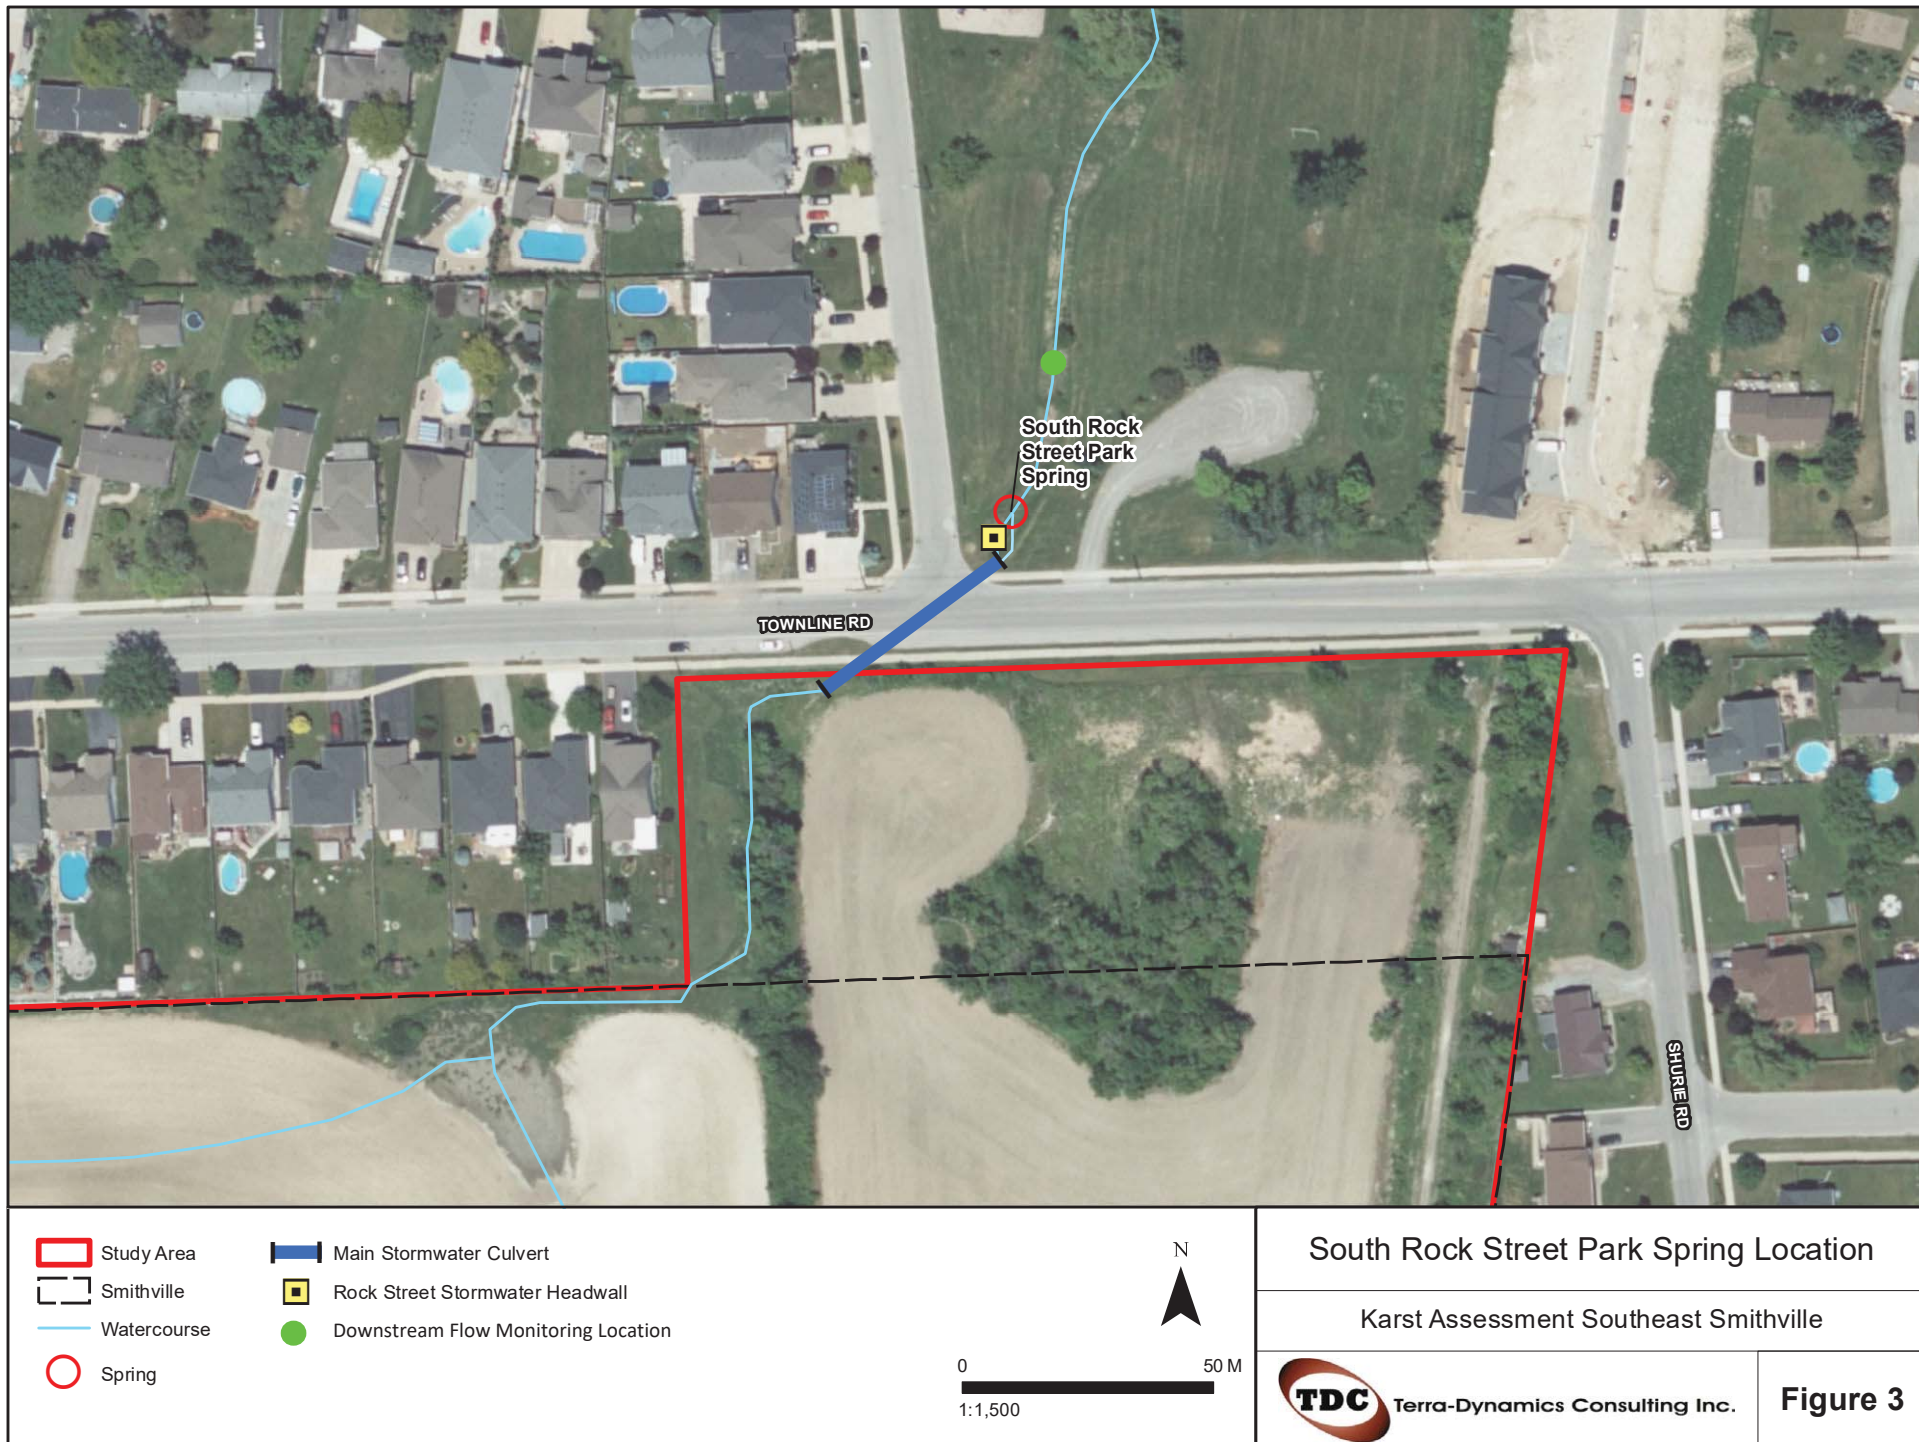
Twenty Mile Creek is located north and east of the Study Area (Figure 2) and it flows in an easterly direction to Balls Falls and subsequently Lake Ontario. A tributary of Twenty Mile Creek is present on the northern portions of the Study Area (NPCA and OMAFRA, 2024) (Figures 1 and 2). After flowing north of the Study Area, this tributary passes under Townline Road and flows northwards through Rock Street Park (Figure 1 and 2).

The Study Area in Southeast Smithville, Ontario is located in the centre of the Niagara Peninsula, above the Niagara Escarpment (Figure 1). The Study Area is situated south of Townline Road, east of Port Davidson Road and west of Shurie Road (Figures 1 and 2). The ground surface slopes generally down from east to west from approximately 191 mASL (metres above sea level) to 186 mASL.

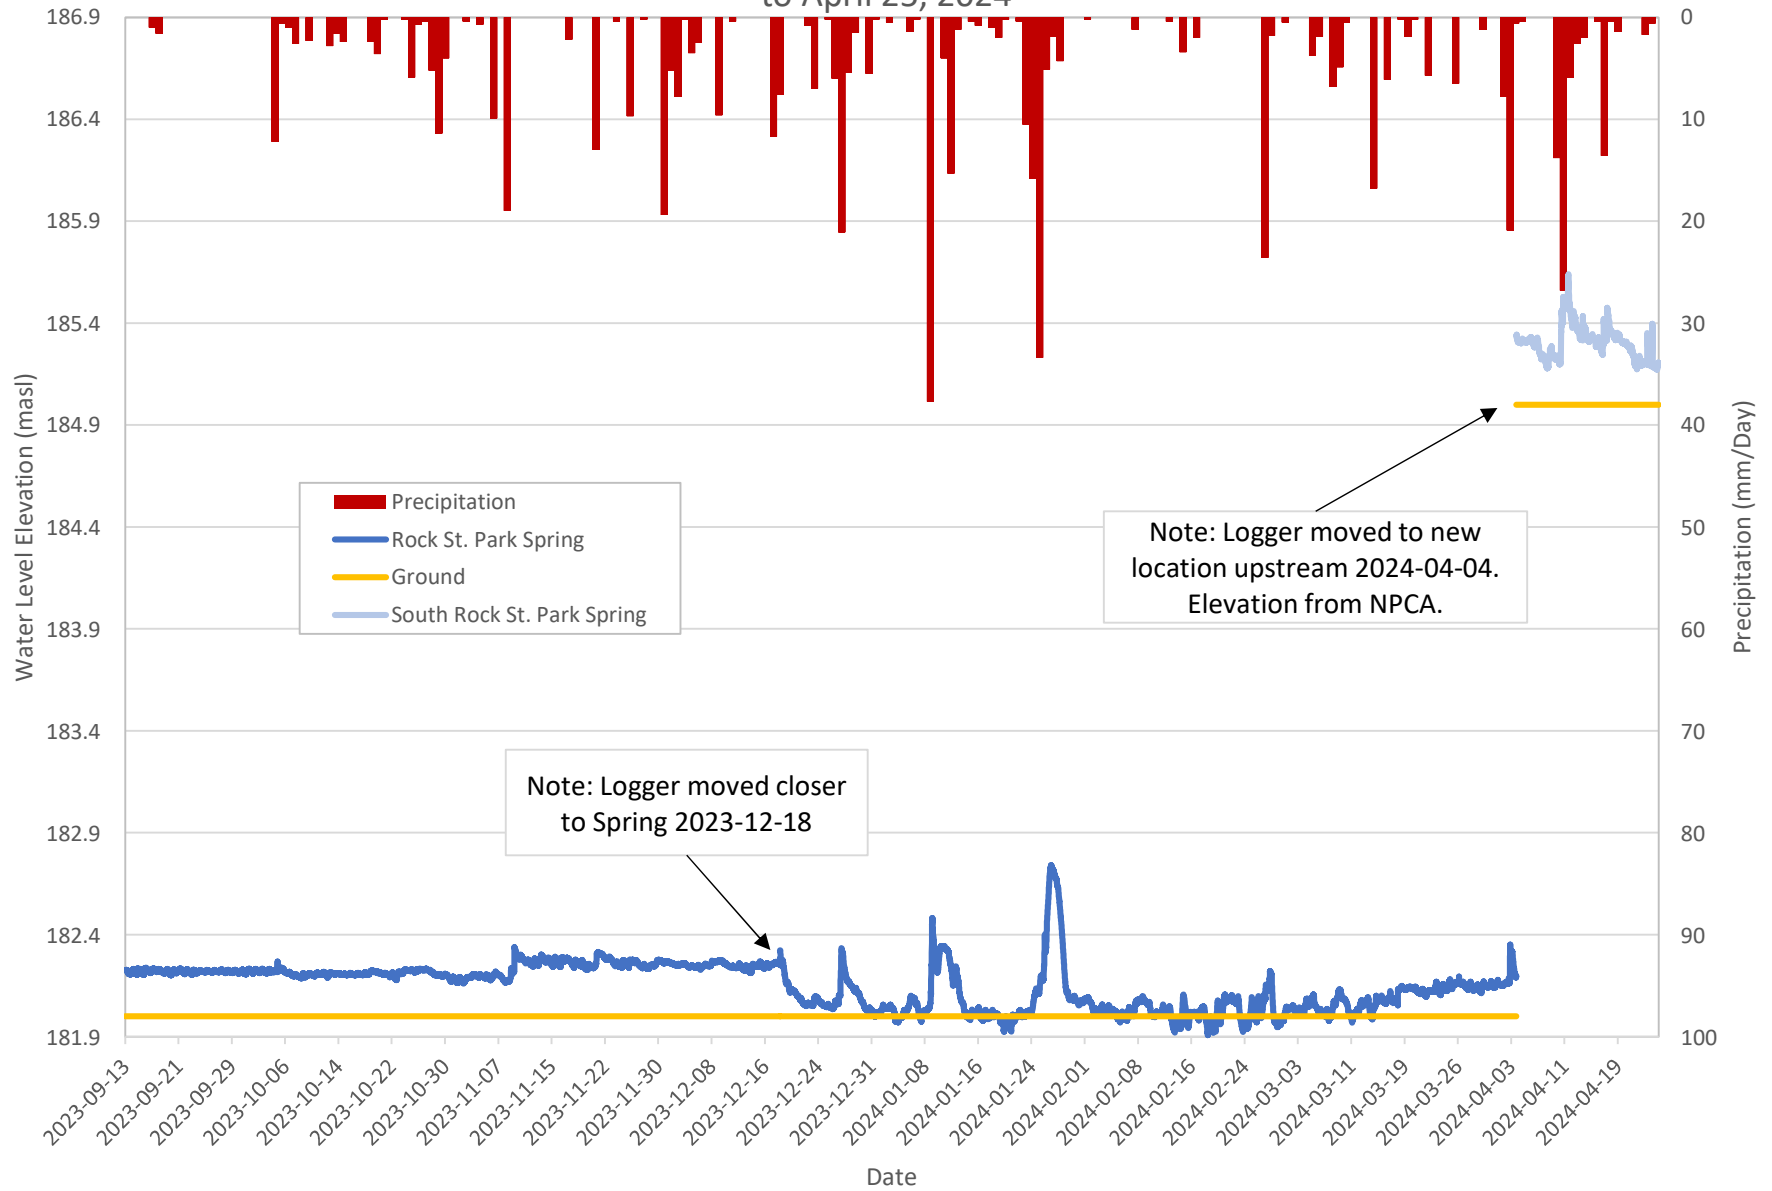
Figure 10: South Rock Street Park Spring Water Level Elevation and Precipitation April 4, 2024
to April 25, 2024

The continuous water level results from April 4 to April 25, 2024, at this location demonstrate that the watercourse at the spring location did not go dry during this time period with a minimum recorded depth of 0.18 metres. An April 9, 2024 site visit noted that there were ponded conditions with no outflow at the spring location. A maximum depth of 0.64 metres was recorded on April 12, 2024, following 26.8 mm of rainfall on April 11, 2024. Well defined responses to precipitation events are apparent as would be expected.

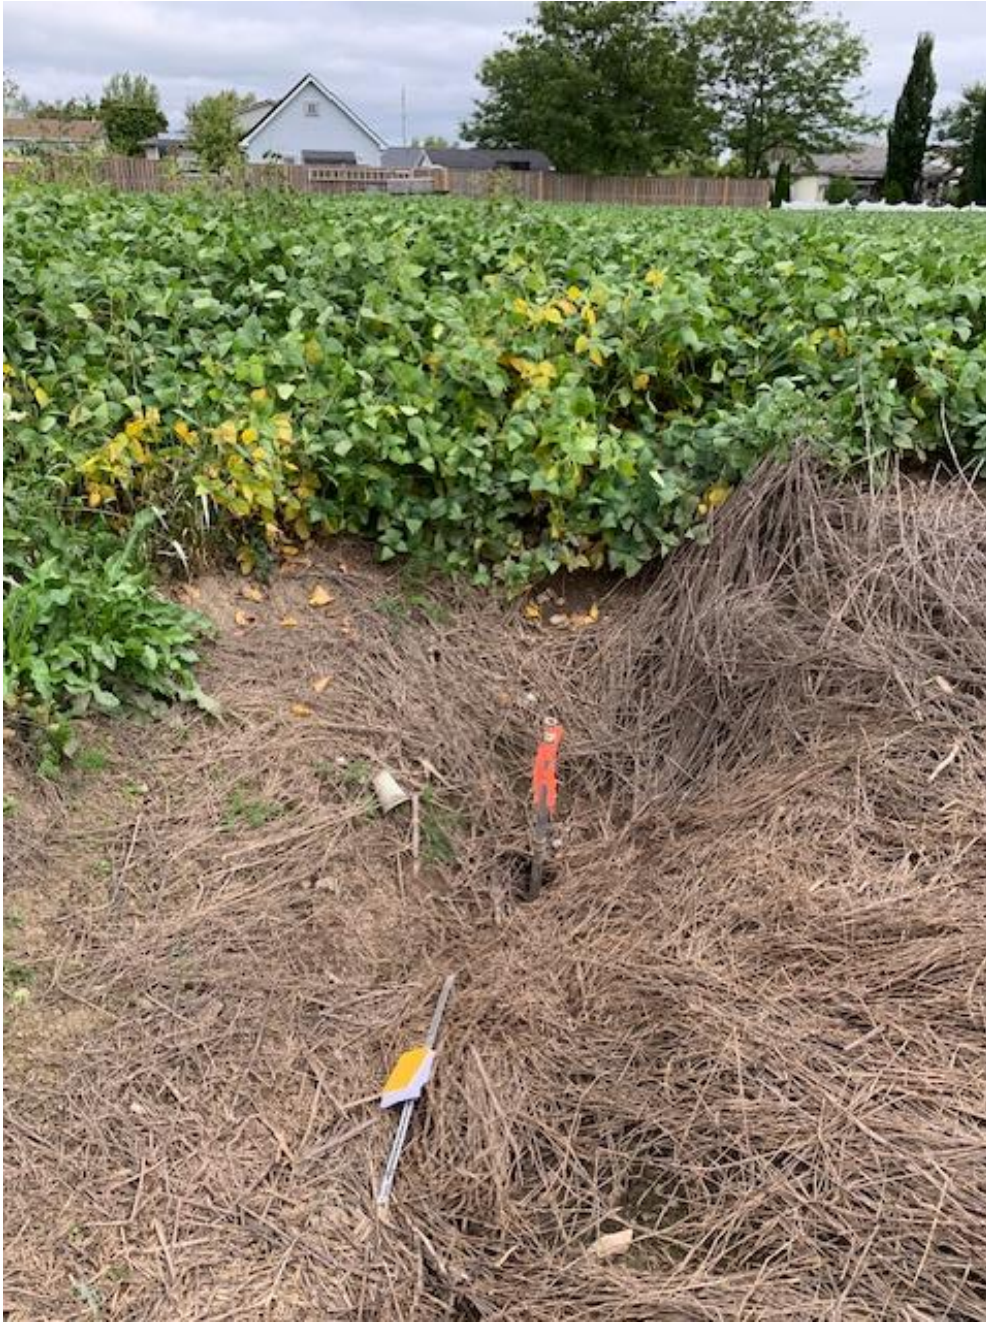
Photograph 1. Northward view of SH-SE-1 with Drive Point installed (contains water level datalogger) and flagged with orange tape (Photograph as taken on September 13, 2023).

On September 13, 2023, SH-SE-1 was instrumented with a Heron Instruments LT (level and temperature) water level datalogger, set to continuously record data at 15-minute intervals. The water level datalogger was installed within a stainless steel, perforated drive point in order to ensure a permanent and stable recording location. Water level data for SH-SE-1, along with daily precipitation data from the Grimsby Mountain Weather Station, ID 6133055 (Climate Data Online) from September, 2023 until April, 2024 is plotted and presented on Figure 8.

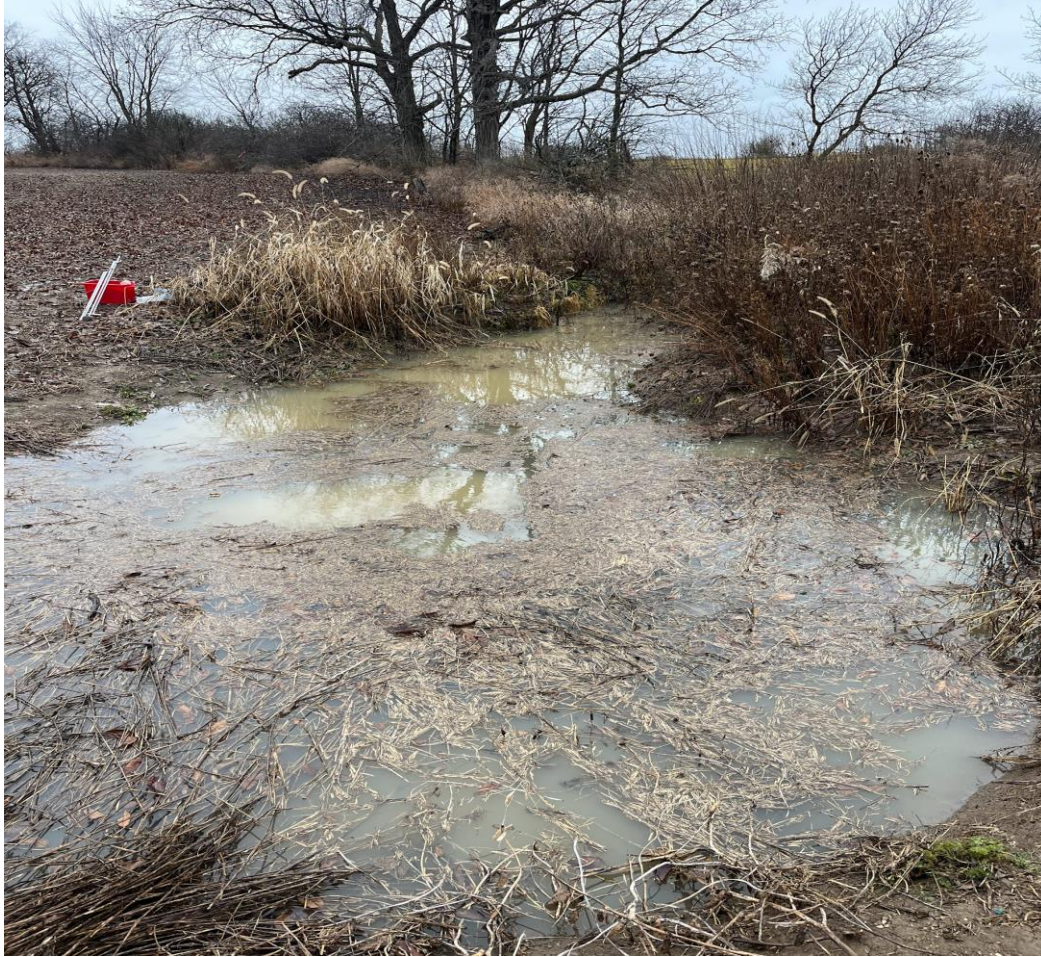
Photograph 2. Southward view of SH-SE-1 when entirely inundated. The Drive Point is under water/not visible (Photograph was taken on January 10, 2024).

During flowing conditions resulting from precipitation and/or snow melt in the fall, winter, or early-spring seasons, SH-SE-1 becomes inundated as is apparent from both Table 3 and the datalogger water level plot presented on Figure 8. The measured flow rate of water sinking into SH-SE-1 was approximately 2.5 to 3.0 L/s. Therefore, on Figure 8, water level values of zero do not necessarily represent dry conditions but rather conditions where flows are less than the infiltration capacity of the sinkhole when the flow is not high enough to cause water to begin filling up the sinkhole. At a flow rate greater than 2.5 to 3.0 L/s, the sinkhole becomes inundated and overflows.

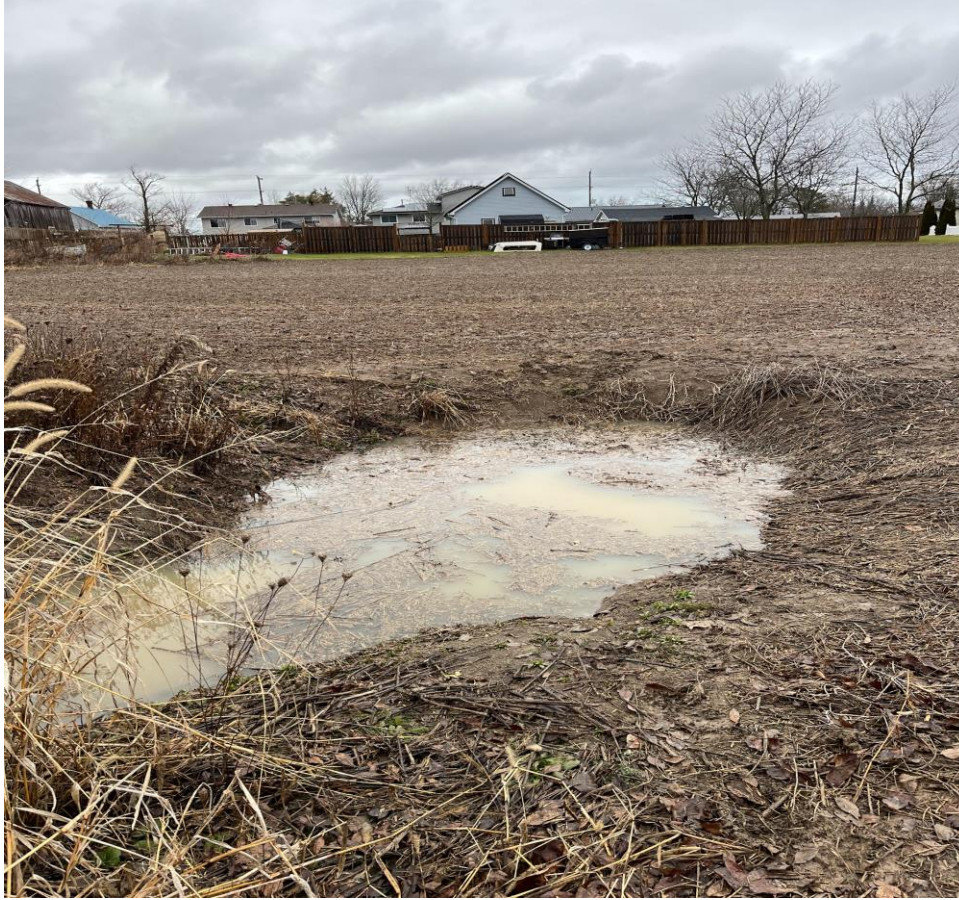
Photograph 3. Northward view of SH-SE-1 when nearly entirely inundated. The Drive Point is under water/not visible (Photograph was taken on January 10, 2024).

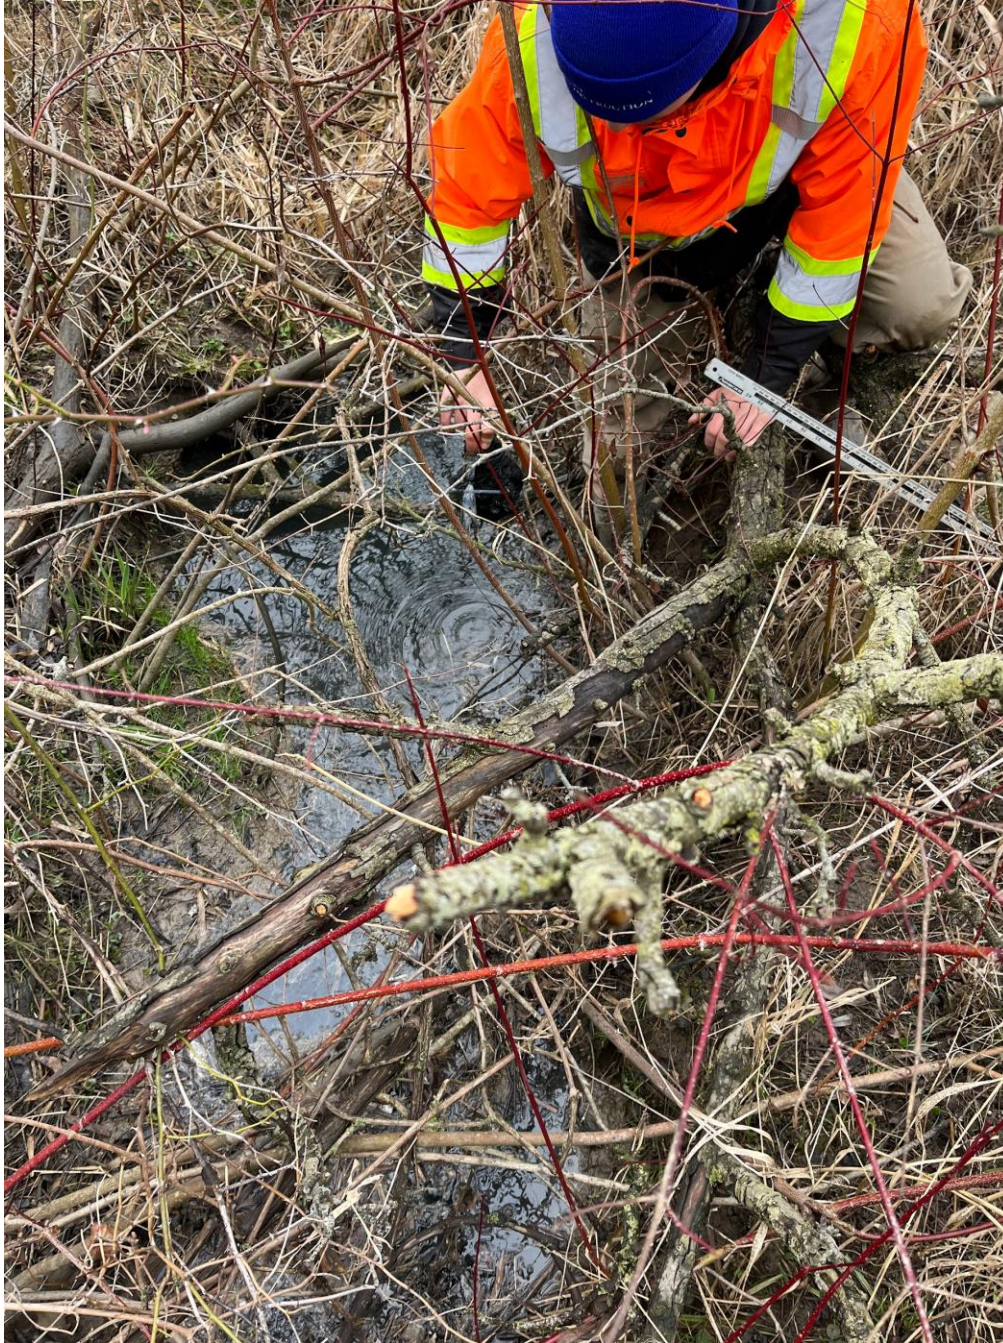
Photograph 4. Water level datalogger location within the Rock Street Park Spring (Photograph was taken on March 15, 2024).

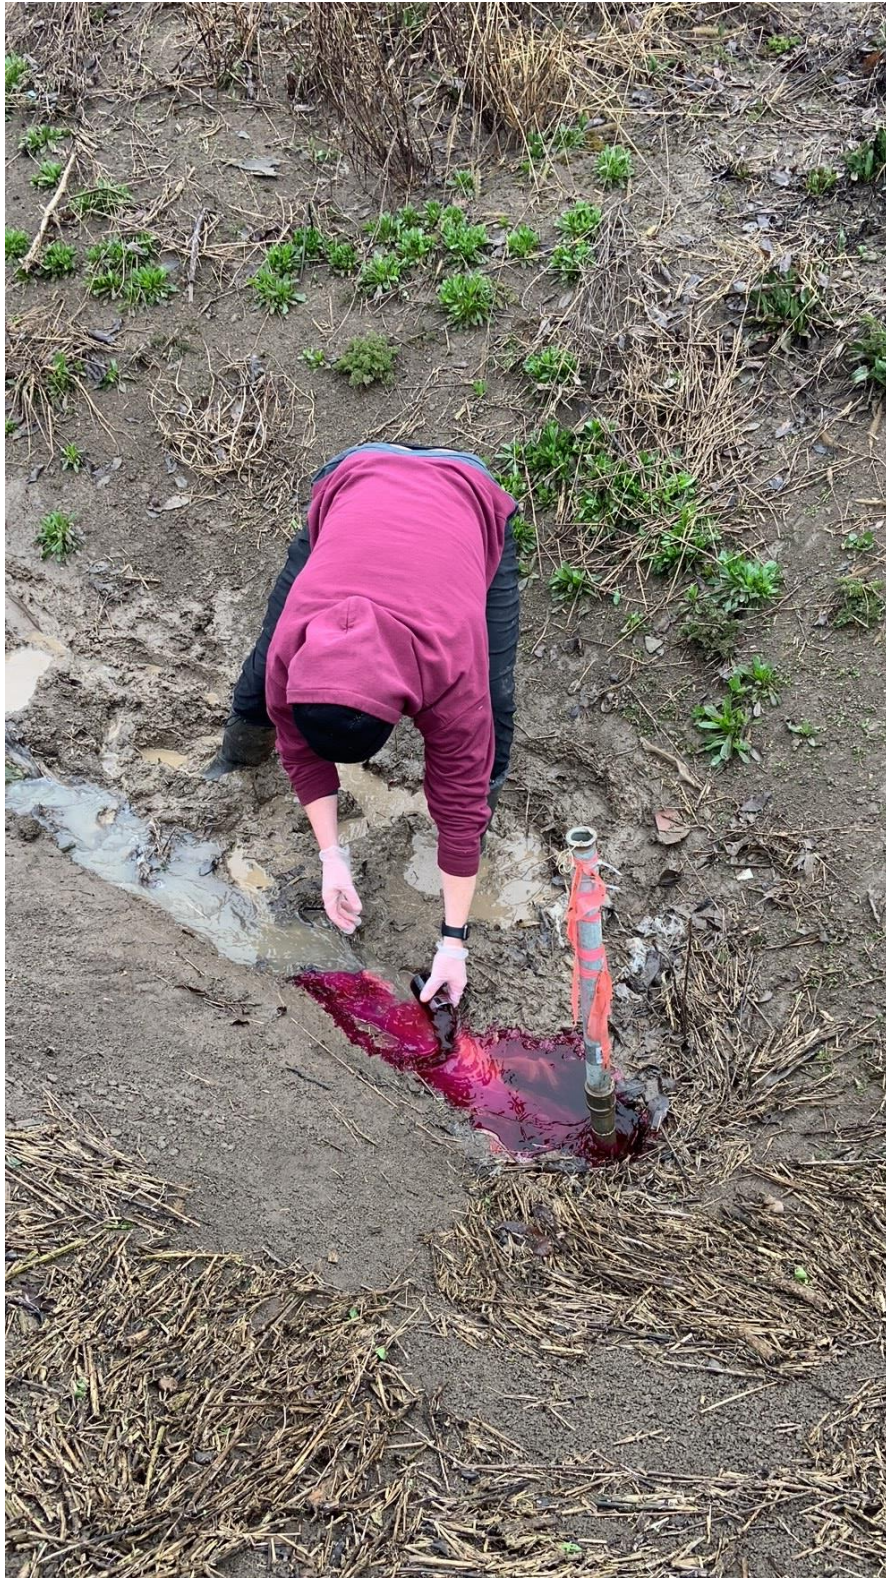
Photograph 5. Southwest view of rhodamine dye injection at SH-SE-1. 200 mL of rhodamine dye was injected at 8:32 am (Photograph was taken on April 4, 2024).

On April 4, 2024, ideal conditions to complete a dye trace were observed at SH-SE-1 (the flow entering the sinkhole was entirely sinking). 1 L/s of flow was measured at SH-SE-1. The study area was visited after 28.7 mm of rainfall was recorded over April 2 and 3, 2024 at the Environment Canada Grimsby Mountain Station (ID No. 6133055).

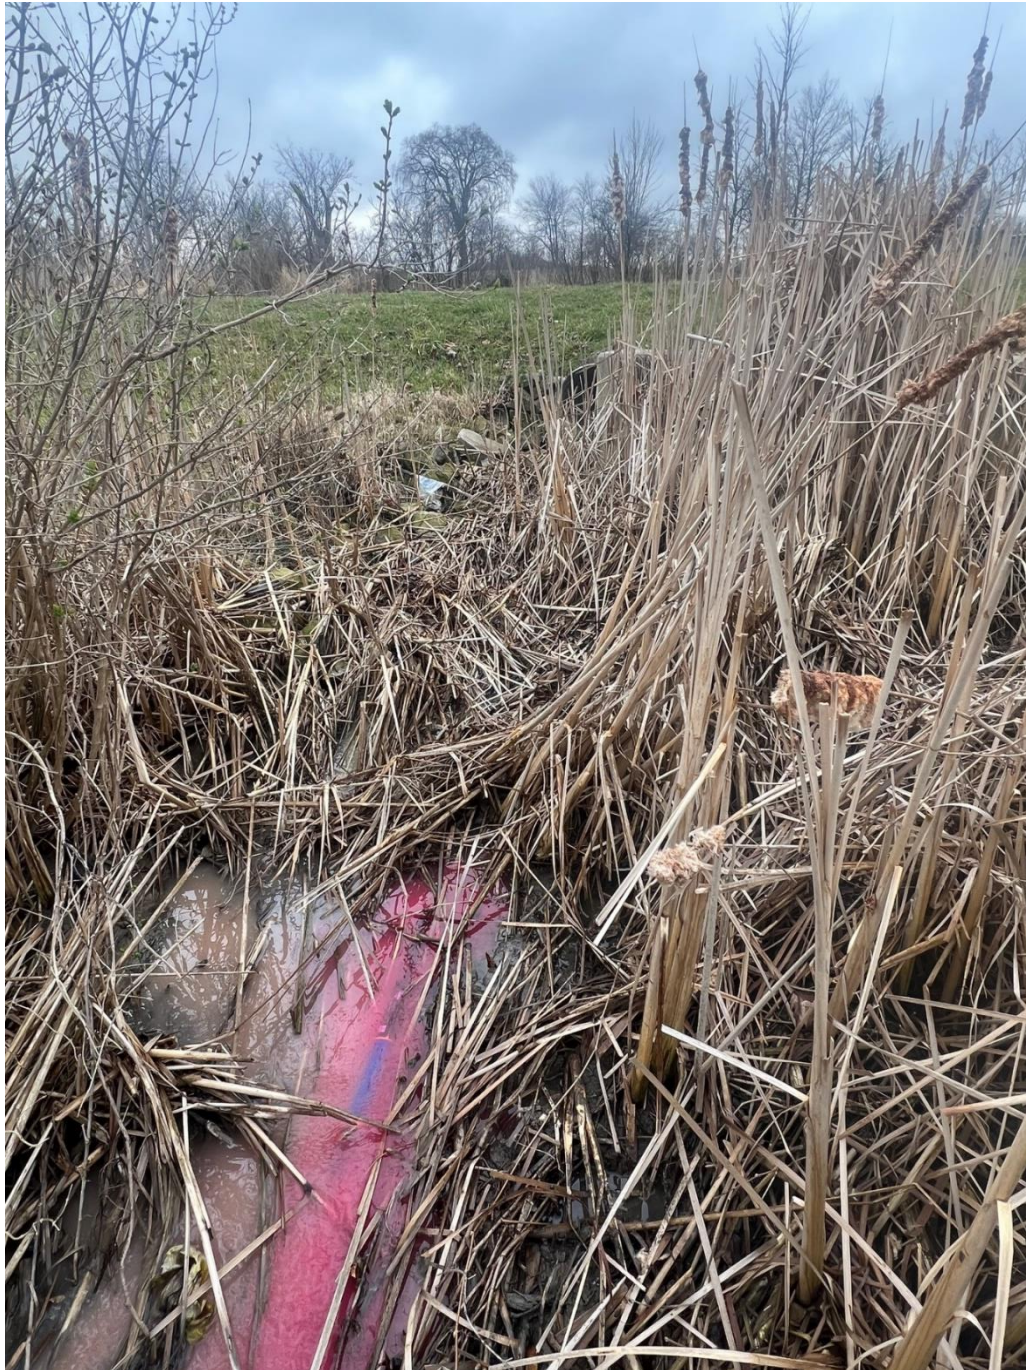
Photograph 6. Southwest view at 12:00 pm of the rhodamine dye within the watercourse flowing through Rock Street Park. This photograph is northeast of the newly identified “South Rock Street Park Spring” which is located on the channel-bottom, immediately north of the culvert passing under Townline Road, at the intersection with Rock Street. Dye was first observed emerging from “South Rock Street Park Spring” at 11:53 am, and following this observation, the rhodamine sonde installed at “Rock Street Park Spring” was moved to this location (Photograph was taken on April 4, 2024).

At 11:53 am, rhodamine was visually observed emerging from a spring in the southern portion of the Rock Street Park (Photograph 6, Appendix 2), at the bottom of the channel of the watercourse that flows in a northeastern direction across the park (Figure 2). Following the visual detection of the dye emerging from South Rock Street Park Spring, the rhodamine sonde was transferred to this location from the Rock Street Park Spring.

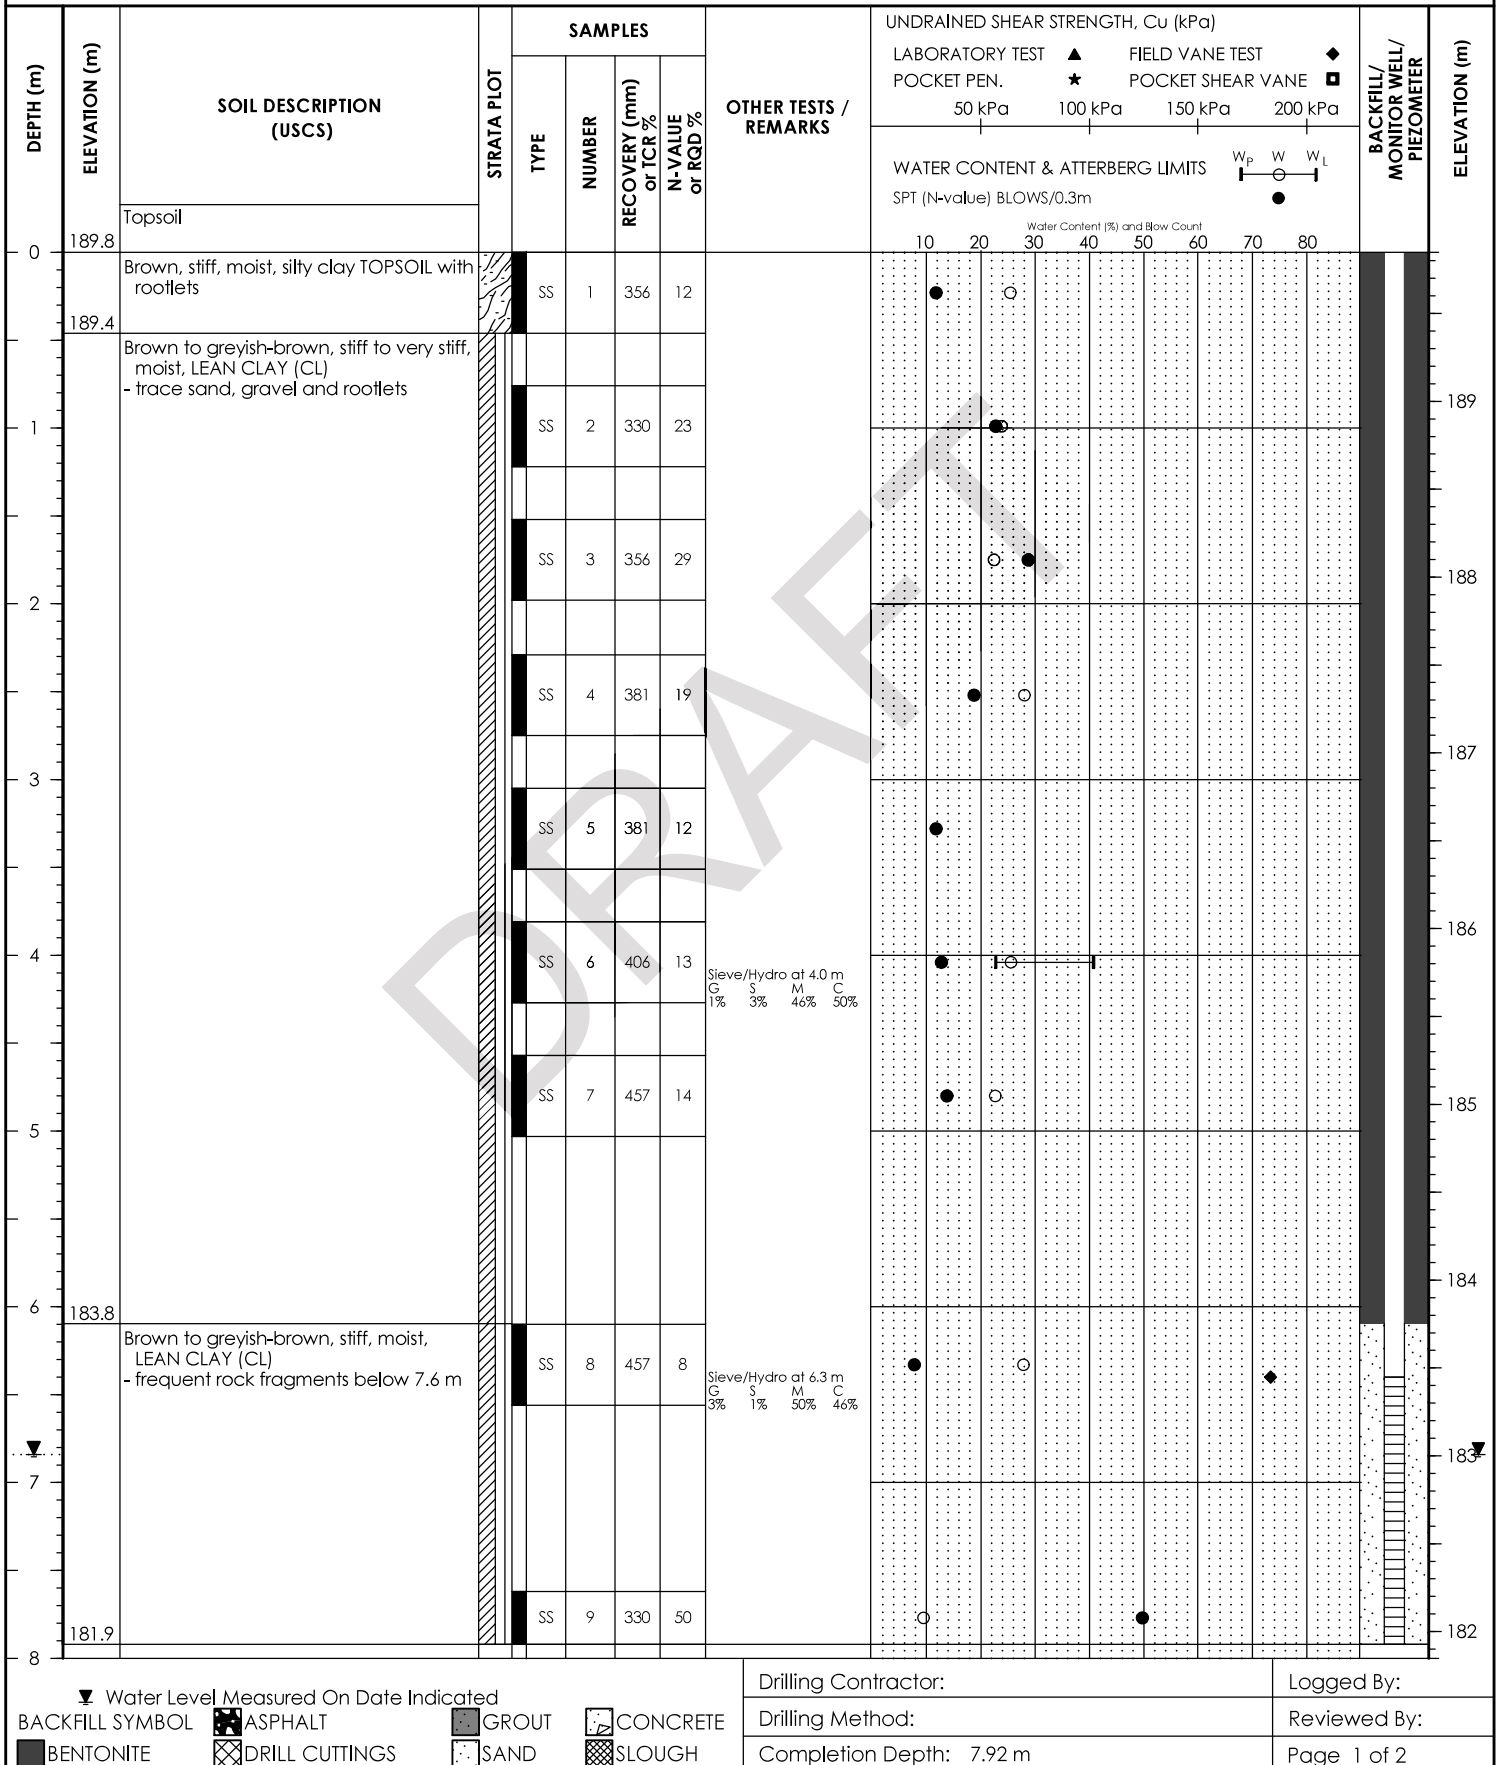
BOREHOLE RECORD

DATE BORED: February 28, 2024

WATER LEVEL: 6.8 m on March 14, 2024
