## Highway 20 & West Street, Smithville, Ontario

Karst Hazard Assessment

GTR-22015175-C1

2024-09-19

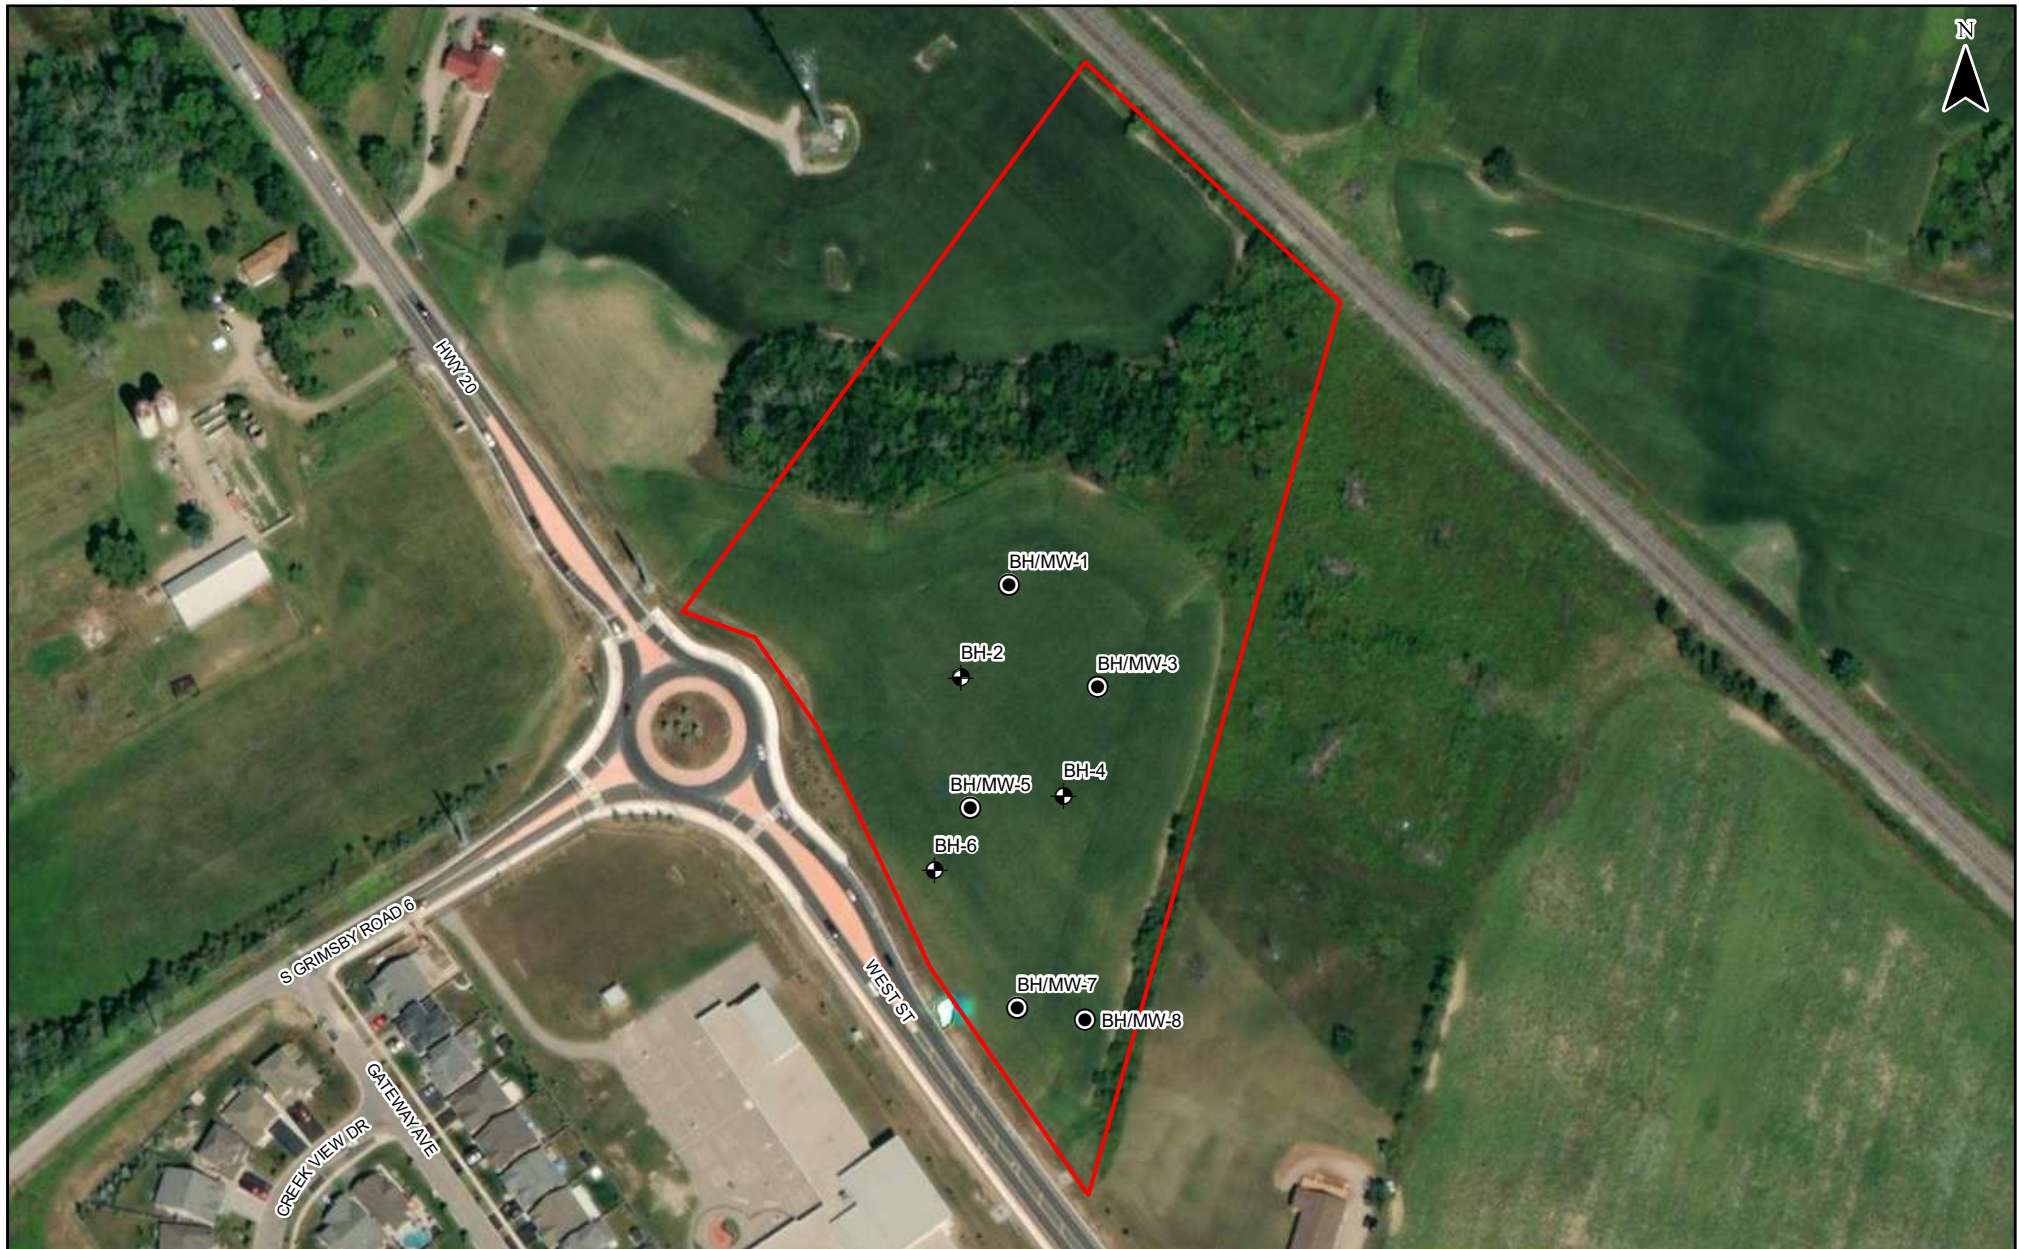
Surface water levels were monitored at two (2) locations (MP/SG1 and MP/SG2) located in the forested area along the stream leading to the sinkhole (karstic feature) between April 21 2023 and October 11, 2023. Results of the monitoring is reported in Table 2-1, and monitoring locations are provided in Figure 2.

Staff gauges and data loggers were installed and measured in two (2) locations, one in the visible karst feature (SG/MP 1) and one upstream of the location (SG/MP 2). Figure 5 depicts the above installations.

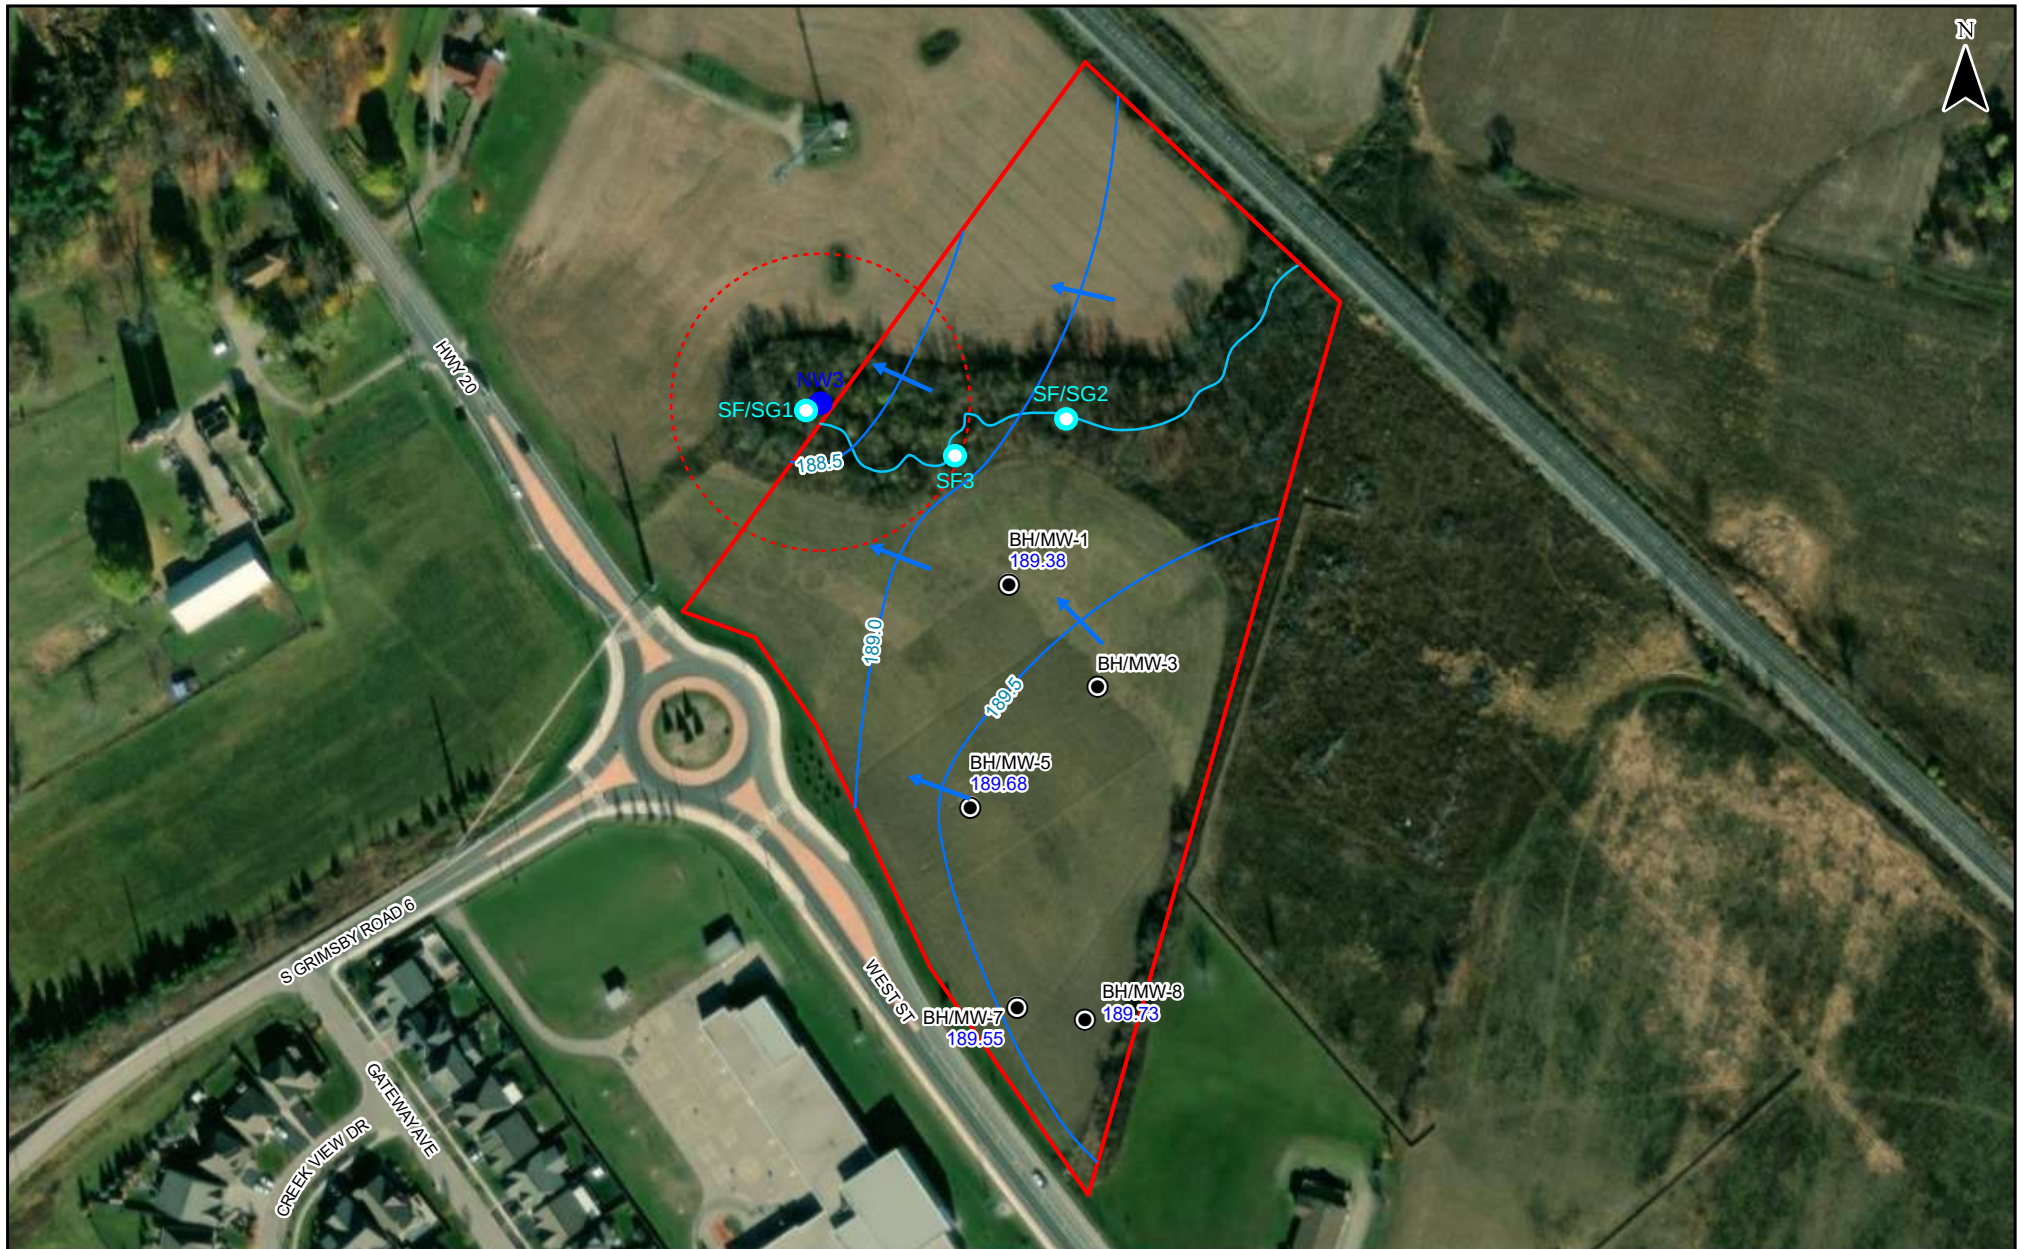
MP1 – 187.092masl

SG1 – 186.317masl

To safeguard its current role in the watershed and karst system, a 50-meter protective buffer (see Figures 4 and 5) must be imposed around this feature. Stormwater management practices employed in the upstream development area should be designed to retain pre-development peak flows and maintain the natural water balance, and drainage plans must be designed to route surface water run-off through filtration measures before entering the karst system. No underground or aboveground storage tanks or salt storage facilities may be placed within the buffer.

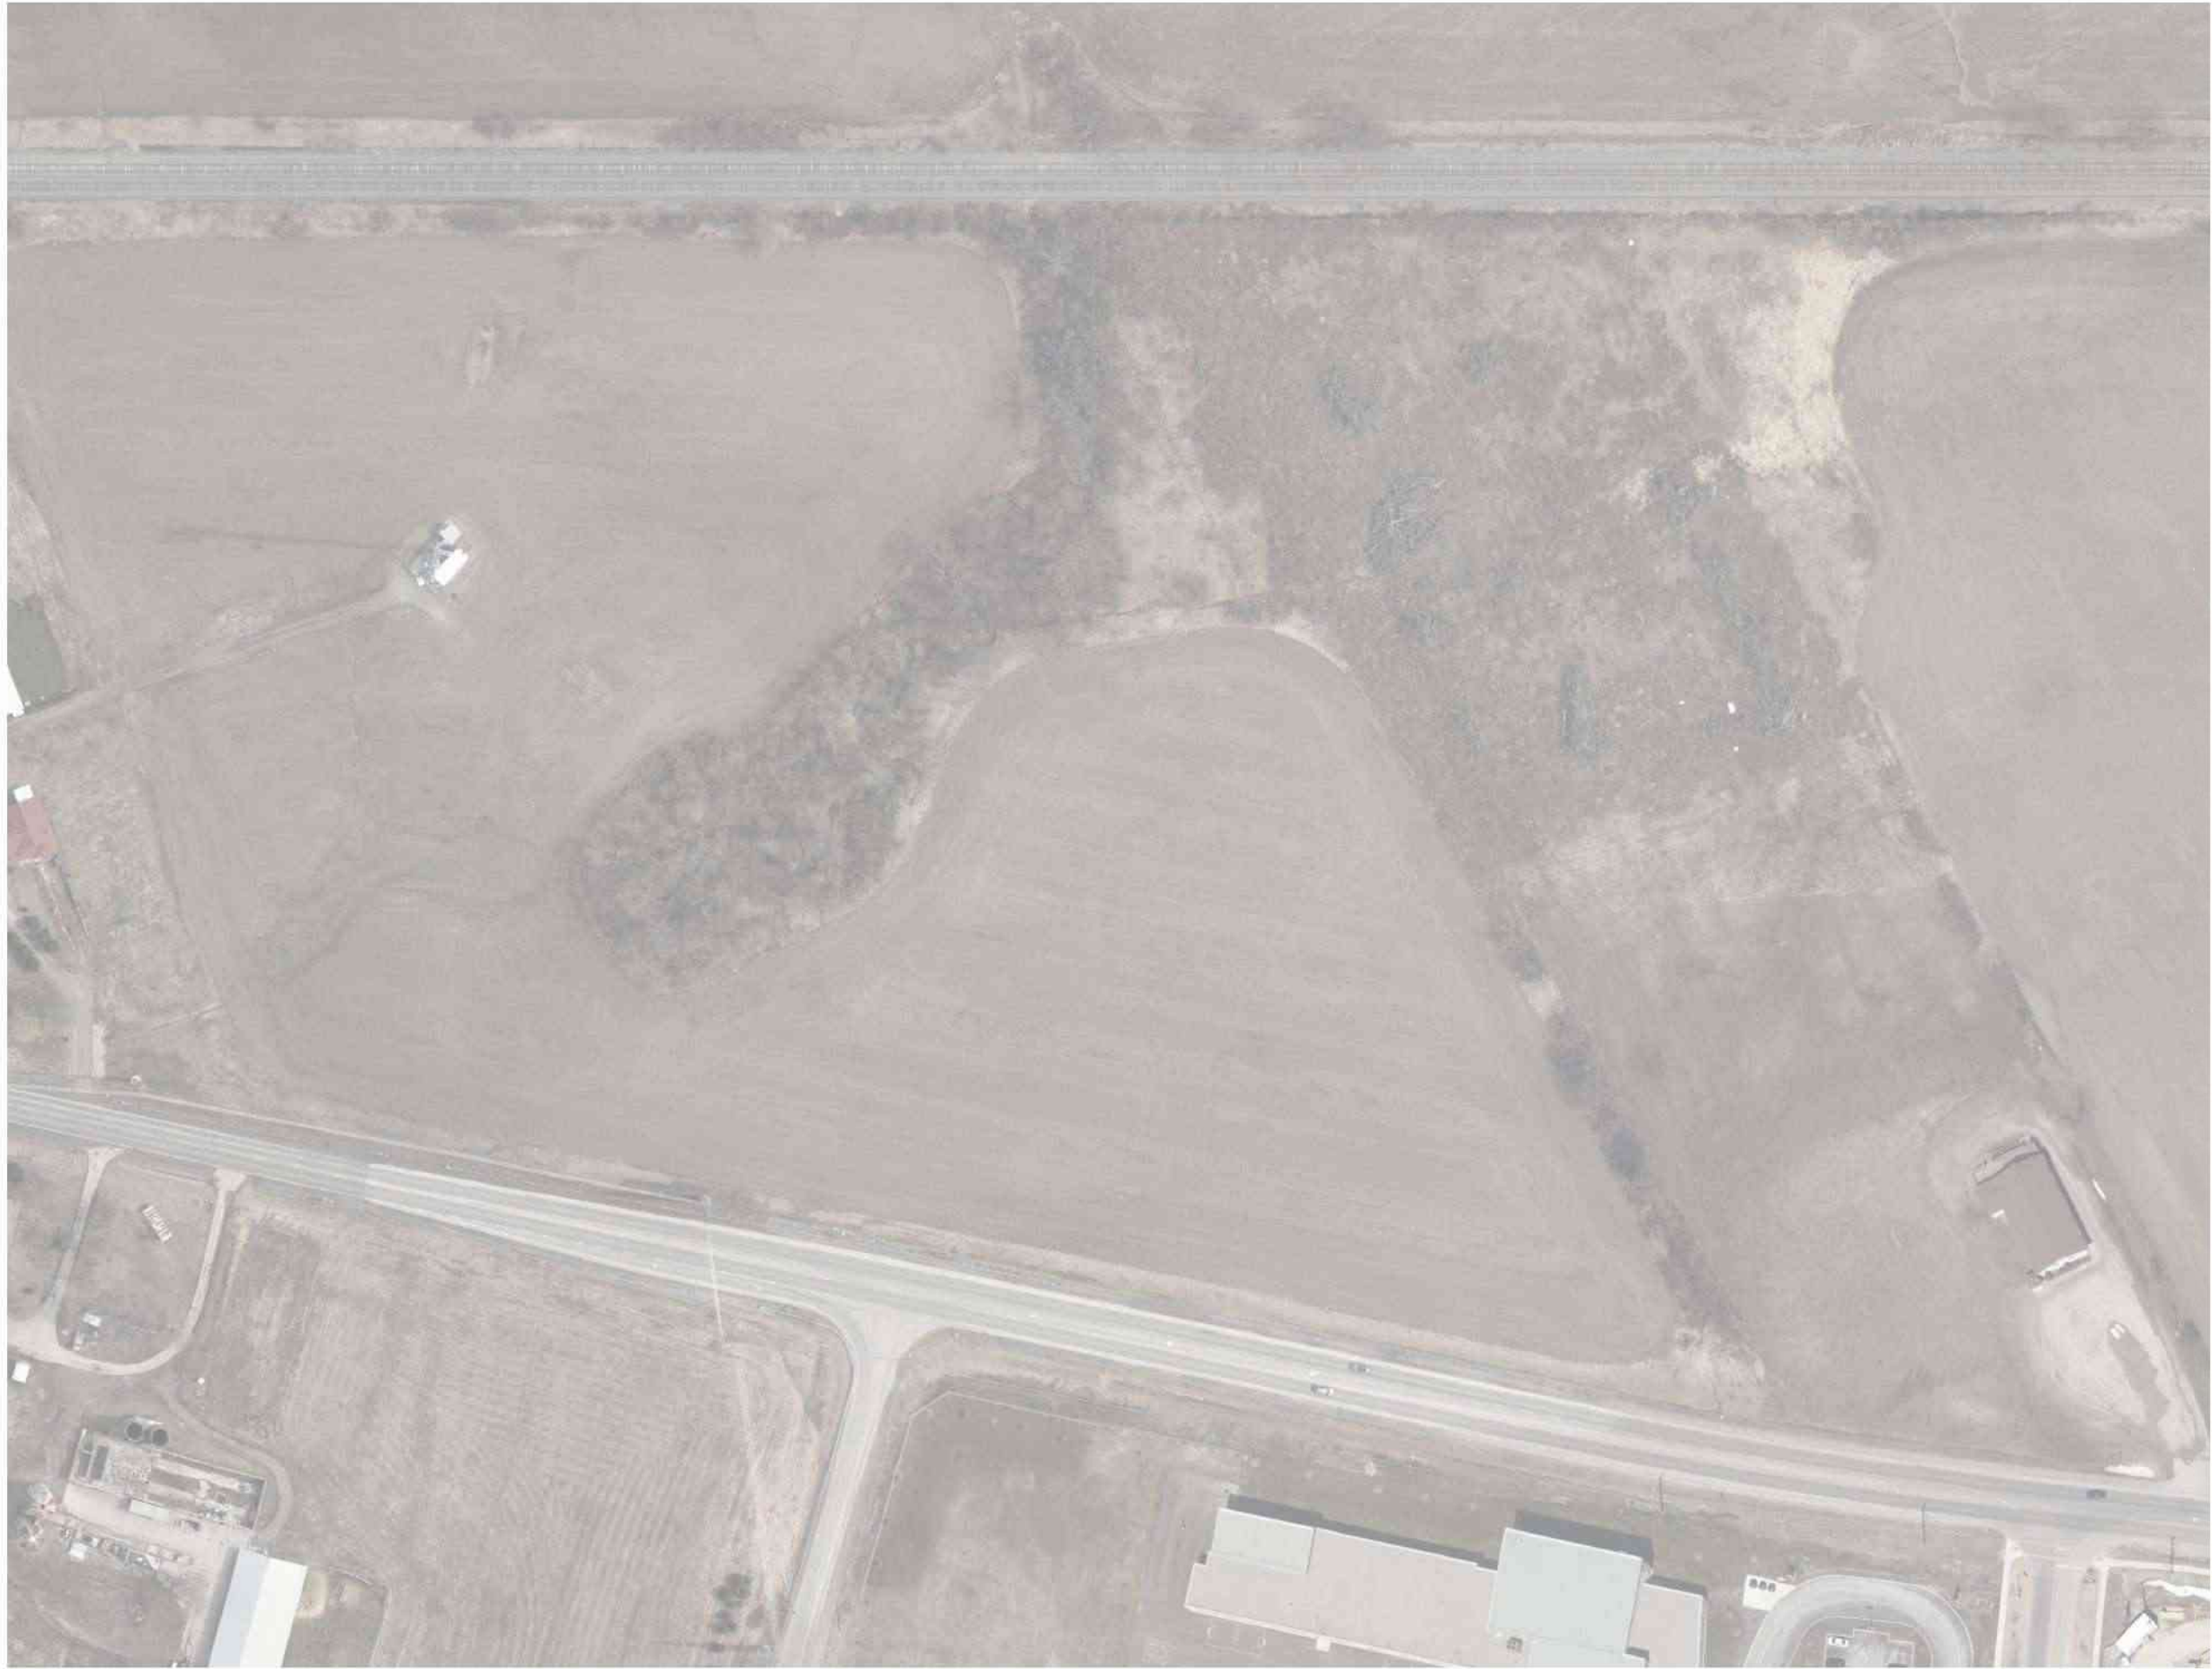
## Appendix G – Additional Potential Karst Features

Additional karst features discovered onsite during construction should be addressed with the same methodology and practices described above, in addition to a 50-meter buffer extending from a new feature. During course of construction in the event that additional karstic features are identified, the same mitigation measures as described above should be employed.
