Scoped Environmental Impact Study

Proposed Plan of Subdivision

7283 Grimsby Road, Township of West Lincoln

Prepared By:
Beacon Environmental Limited

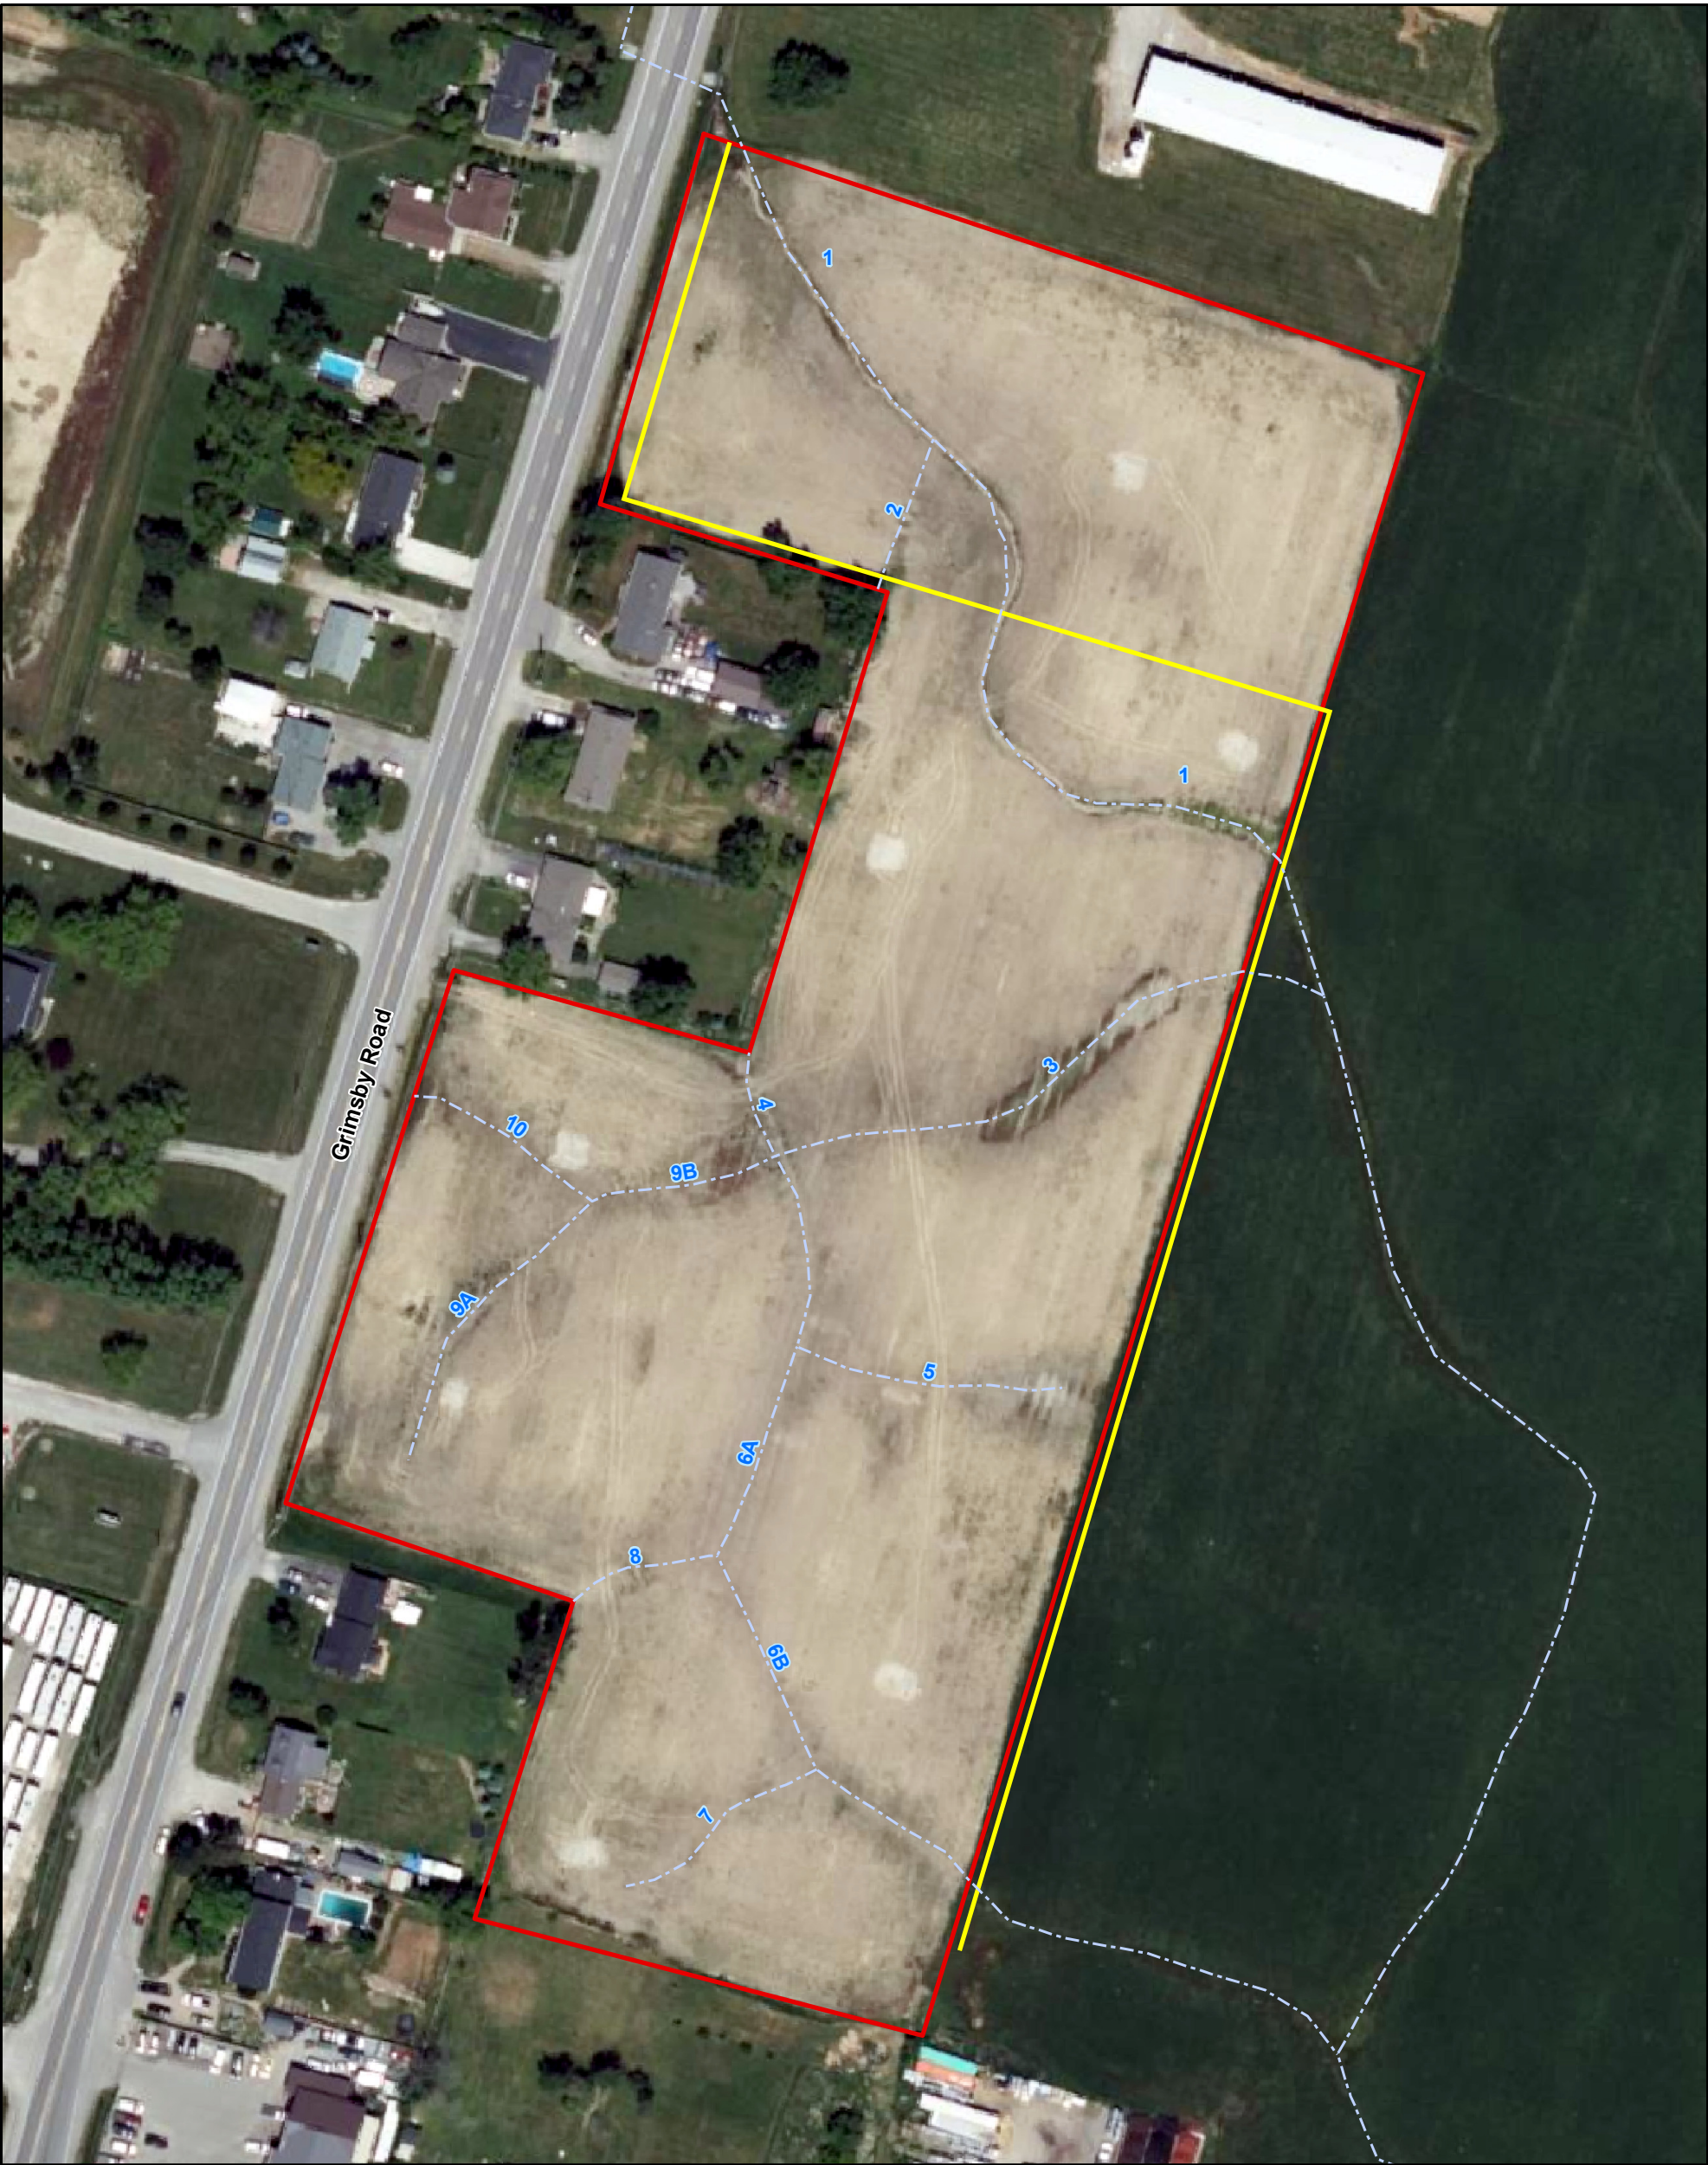
Figure 2

For the subject property, ten (10) headwater drainage features were assessed following the HDFA. A brief summary of each is provided below. The location of these features is shown on **Figure 2**.

This feature is located in the eastern portion of the subject lands and receives flow from upslope drainage features 4, 9 and 10. The feature is a narrow 20 cm wide, 2-5 cm deep ploughed channel. No defined banks or bed is present. Flow was minimal in March, and only standing water was present in April (**Photographs 12 & 11**). No water was present in May and June.

This drainage features conveys flows from upstream features 7 and 8 southward to the east boundary. Two sections were identified. Section 6A supports standing water and shallow broad flows only occurring during March and April (**Photographs 17 & 18**). No flow was present by May (**Photograph 19**). No defined banks or bed is present.

Located in the western portion of the subject lands along Grimsby Road this feature conveys surface water through the farm field to drainage feature 6A. Two sections were identified. Section 9A supports standing water and shallow broad flows only occurring during March and April (**Photographs 24 & 25**). No defined banks or bed is present, and the feature is regularly ploughed through.

The entire development area will be graded, and all the headwater drainage features will be either removed or altered. The first section of feature 1, directly south of Grimsby Road will not be altered and remain flowing through farmed field. The southern section of feature 1 will be realigned via the construction of a grass swale along the north boundary and then southward along the east boundary to where the feature currently exits the property. The plan in **Appendix D** shows a cross section of the grass swale, which is 0.5 m deep with a 1.2 m flat bottom with sides at a 1:3 slope.

The site will be graded so that current flows from features 6, 7, 8, 9 and 10 will be directed via grass swale to a grass swale along the south boundary, which will then go northward along the east boundary to discharge at the location where feature 6B currently exits the property. Flows associated with features 4 and 3 will be directed to discharge to the current exit location of feature 1. Stormwater associated with Joshua Court will be collected and conveyed to the stormwater pond, which will discharge southward to location where feature 6B currently exits the property.
