Subwatershed Study Phase 1: Characterization and Integration

Smithville Subwatershed Study and Stormwater Management Plan
Township of West Lincoln
TPB198161

Township of West Lincoln

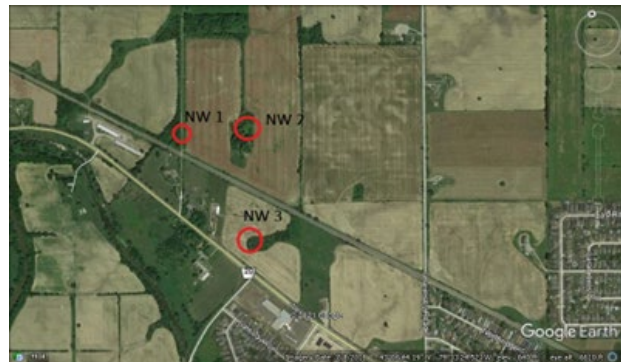
Figure 3.4.2. Northwest Karst Features

Sinkholes range from a very small surface depression taking water from a culvert (SE 3) to a large, significant features (SW 2 and NW 3) draining unnamed tributaries of Twenty Mile Creek. SW 2 lies about 440 m due west of SW 4 which is known to drain into the Smithville Cave (Worthington 2002). Most streamsinks and the loosing stream (SE 2) are the result of opportunistic capture either naturally or due to human activities.

Table 3.4.1. Summary Description of Karst Surface Features Found within the Study Area (Feature numbers shown of maps in Figures 3.4.1 to 3.4.4. Preliminary constraint levels are shown as low (green); medium (yellow); and high (red). SW4 and SE5 are outside the study area (clear).

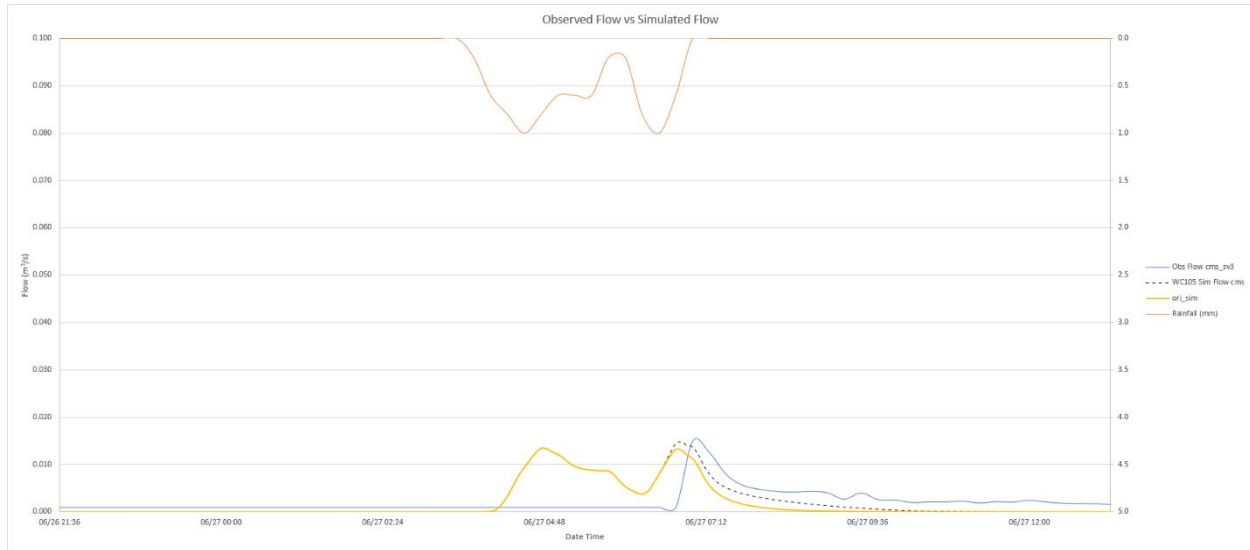
Figure 3.5.4. Comparison of Observed and Simulated Hydrographs for June 27, 2020 Storm Event

the observed hydrographs for peak flows and runoff volumes. Comparison of observed and simulated hydrographs for validation storm events, using the original and adjusted PCSWMM model parameters, are presented in **Figure 3.5.4**, **Figure 3.5.5** and **Figure 3.5.6**.

The comparisons of the selected storm events show that the overall shapes of the peak flow responses largely correspond to the observed runoff responses for the validation storm events.

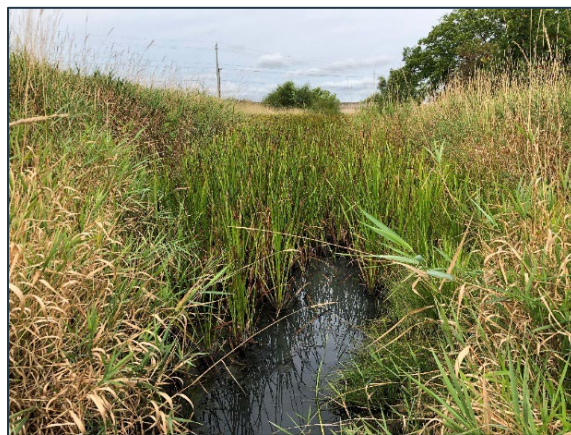
Figure 3.6.1. NC5 in August, 2020

vegetated with grasses and is typically stable. For the purposes of this analysis the high flow channel was used as a proxy of the bankfull channel, but it has not been confirmed how frequently the channel overtops. The calculated channel characteristics in Table 3.6.6 should be considered rough estimates only, and may not correspond to a 2-year or 1.5-year flow. The channel has mixed substrate which includes predominantly clay (21.5%), silt (10.8%), sand (30.5%) and gravel (37.3%). The erodibility of this channel is controlled by the cohesive clay substrate, the gravel fraction, the resistance of vegetation and the channel slope, which is extremely low (estimated 0.08%). Due to the vegetation in the channel, a roughness value of 0.04 was used.

The channel was 10.8 m to 11.8 m wide and 1.1 m to 1.3 m deep on average, and ranged up to 16.0 m wide and 1.5 m deep at a pool. Bankfull discharge within the representative run-type cross-sections was 1.59 m³/s to 3.99 m³/s (at 0.08% slope and n = 0.04). At the bankfull flow, the channel produces velocities of 0.38 m/s to 0.51 m/s and shear stresses of 3.13 N/m² and 4.78 N/m².

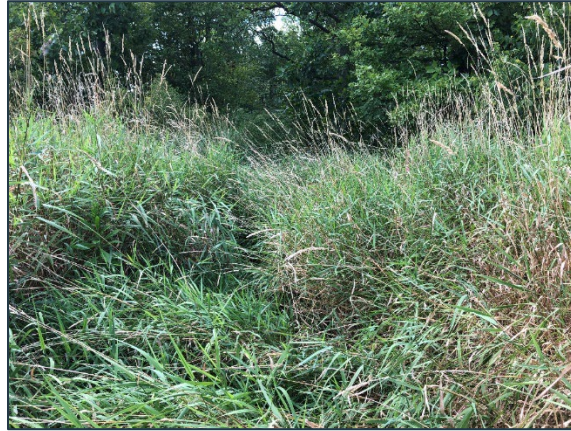
Figure 3.6.2. SC1(2) in August, 2020

SC1(2) is an ephemeral creek which has been previously straightened. While channel banks were discernable, the channel is more representative of a low flow channel rather than a bankfull channel, and banktops may represent an excavation limit. The channel runs through a wide grassy floodplain within the reach, and through forested wetland reaches upstream and downstream of SC1(2). The channel bed was composed of compact clay (51.1%) and silt (47.5%), and was densely vegetated with grasses and reeds at the time of the site visit. The slope is low (0.14%). Morphological controls include vegetation, the low slope, and clay content of the substrate which provide cohesion. The estimated roughness coefficient (Manning's N) was high (N = 0.07) due to the density of the vegetation in the channel.

The channel was 3.8 m wide and 0.3 m deep on average, and ranged up to 4.0 m wide and 0.5 m deep at a pool. Bankfull discharge within the representative run-type cross-sections was 0.12 m³/s (at 0.14% slope and n = 0.07). At the bankfull flow, the channel produces velocities of 0.16 m/s and shear stresses of 2.14 N/m².

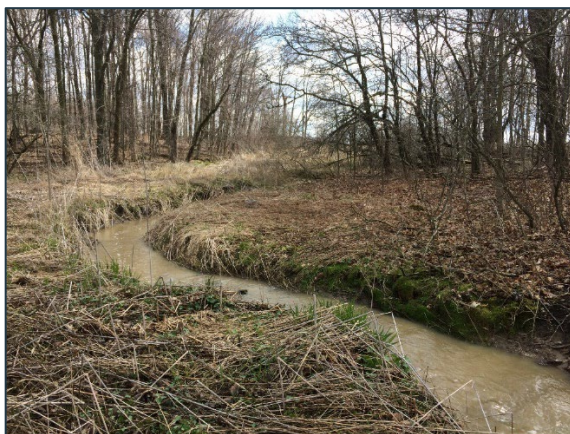
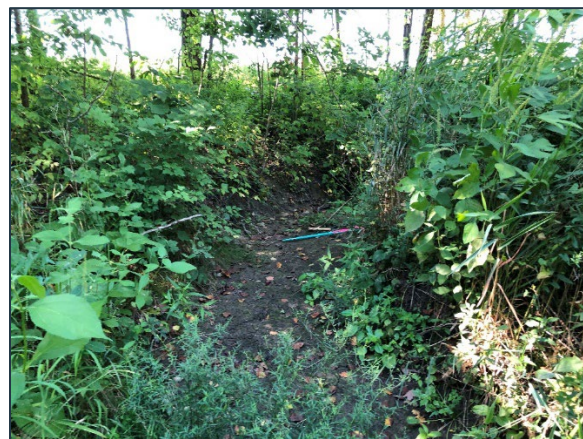
Figure 3.6.3. TM4(6)1-1 in April, 2020

This channel was well-defined and a bankfull stage was identifiable, although the bankfull channel may not correspond to the 2-year flow. The channel bed was composed of compact clay based on a visual inspection. A small amount of scattered gravels and occasional cobble was present intermittently throughout the reach. This material was not embedded into the clay and covered only a small portion of the creek bed where present. As such it was not included in the bulk sample for grain size analysis as it did not appear to contribute to channel stability. The grain size distribution indicates that the bed material is composed predominantly of clay (48.5%) and silt (31.9%) with smaller components of fine, medium and coarse sand, and less than 1% gravel (diameter >4.75mm). The channel did not have well-developed riffle and pool morphology. The bulk sample was taken from a cross-section with run-type morphology. Tree, shrub and grass roots provide some bank cohesion, and little vegetation is present within the channel. The cohesive clay-silt substrate is a controlling factor on critical thresholds in this reach.

The channel was 2.2 m to 3.0 m wide and 0.43 m to 0.53 m deep on average, and ranged up to 4.8 m wide and 0.6 m deep at a pool. Bankfull discharge within the representative run-type cross-sections was 0.57 m³/s to 1.31 m³/s (at 0.96% slope and n = 0.035). At the bankfull flow, the channel produces velocities of 0.92 m/s to 1.28 m/s and shear stresses of 17.86 N/m² and 28.94 N/m².
